**ANNUAL CCR LANDFILL INSPECTION
SPURLOCK STATION POWER PLANT**

**EAST KENTUCKY POWER COOPERATIVE
COAL COMBUSTION RESIDUAL RULE COMPLIANCE**

JANUARY 2017

REV. 1 (3/6/2017)

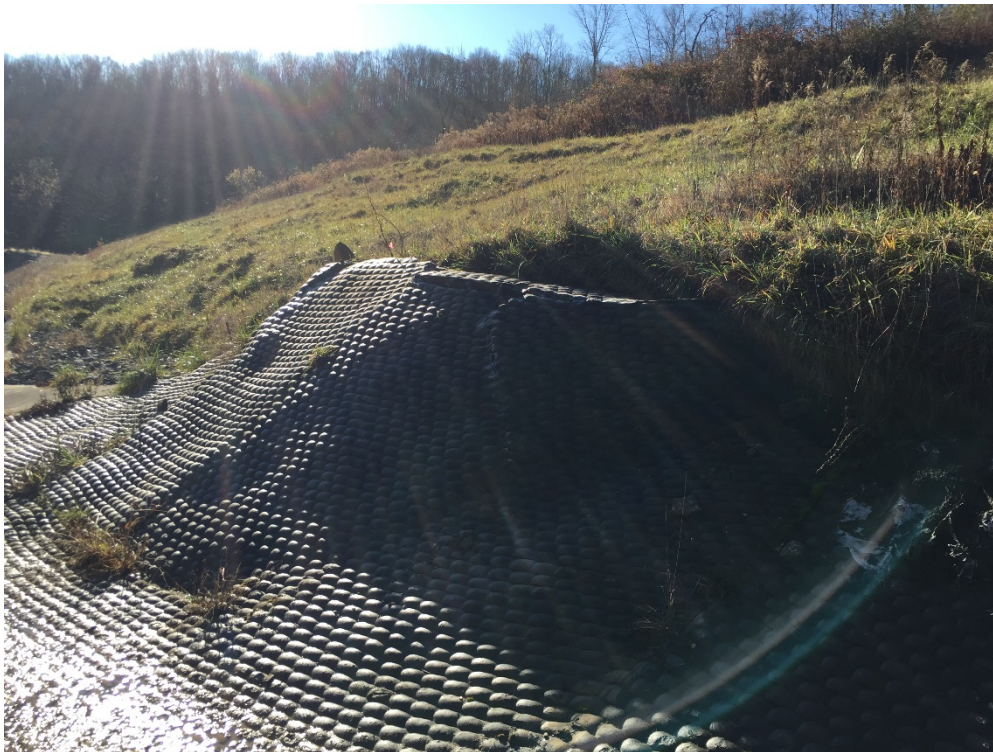
Photograph Number: IMG-7472

- 1) Concrete drainage ditch to Pond 1, damaged concrete at outlet due to impacts from slough on south slope above Pond 1. Repairs are planned by EKPC to take place during 2017 (Photo IMG-7472).

Description: Outside the landfill limits - Ditch damage from Pond 1 slough, south slope

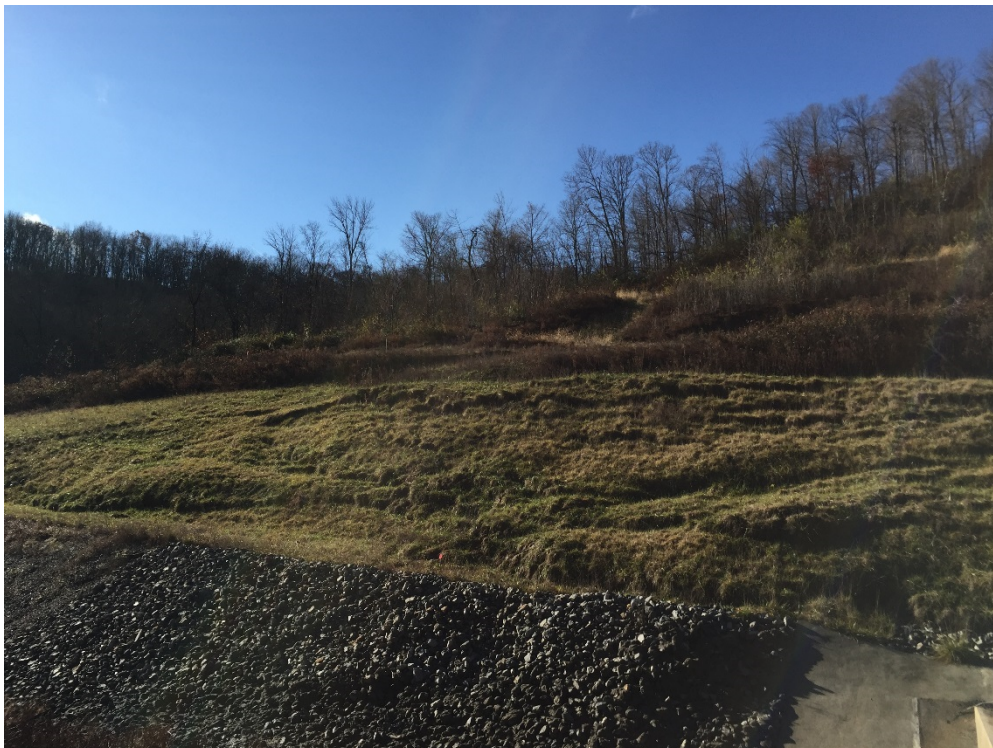
Photograph Number : IMG-7474

- 2) Soil slough above Pond 1 and concrete drainage ditch. This deficiency is currently being studied by EKPC to determine remedial measures (Photo IMG-7474). This item is located outside the landfill disposal footprint.

There are two (2) conditions listed above that have potential to disrupt the operation and safety of the CCR unit or appurtenant structures. The sloughs observed on the north and south slopes of Pond 1 and the concrete drainage ditch have the potential to temporarily disrupt the operations of the access road, ditch and Pond 1. The anticipated disruption would be very temporary (estimated at a couple days to 1 week), minimizing the sediment and leachate storage capacity of Pond 1 and surface water/leachate conveyance capacities of the concrete drainage ditch and blocking the access road to the eastern portion of the landfill. Based on visual observations during this inspection, the north slough movement is minimal. Therefore, it is recommended that EKPC continue to visually monitor the north slope above Pond 1 until such time that corrective measures may be necessary.

Description: Outside the landfill limits - Slough above Pond 1 and ditch, south slope

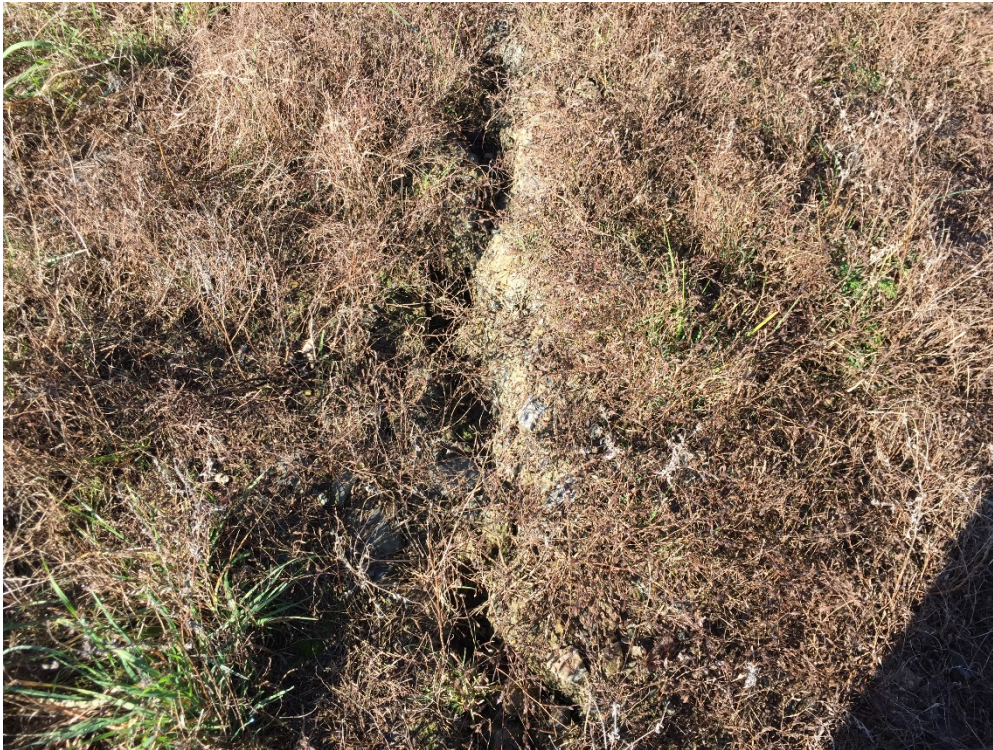
- 3) A slough was observed above Pond 1 on the north slope. This slough has been observed previously by EKPC and documented as moving slowly (Photo IMG-7485). This item is located outside the landfill disposal footprint.

Photograph Number : IMG-7485
Description: Outside the landfill limits - Evidence of slough above Pond 1, north slope

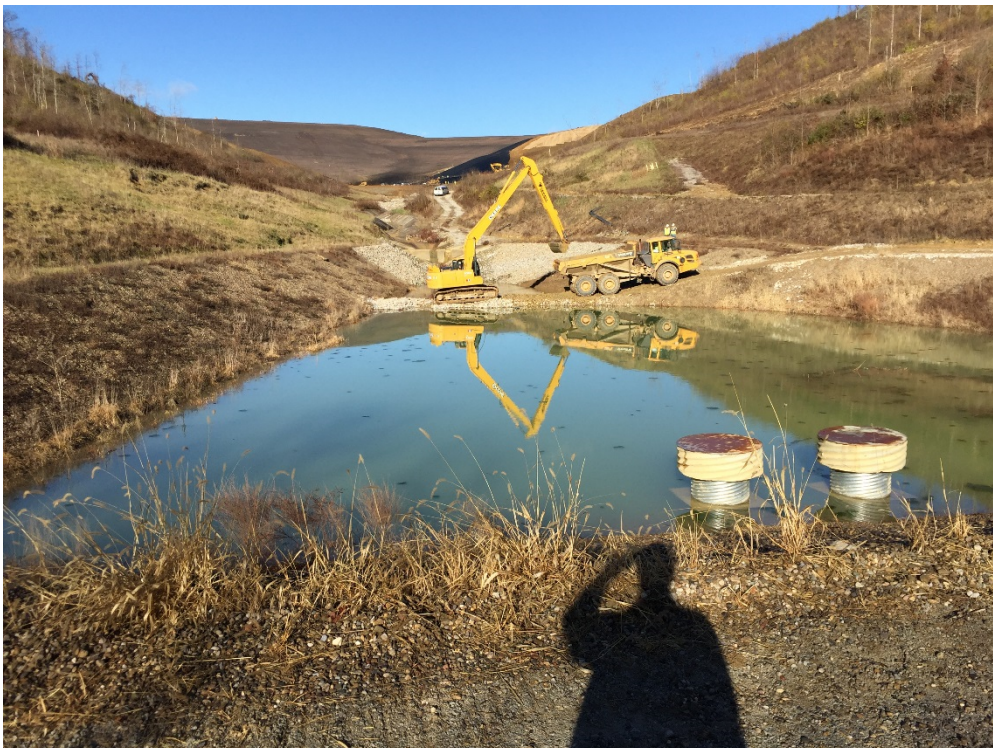
Photograph Number: IMG-7482
Description: Pond 1, looking west. Cleanout activities taking place.

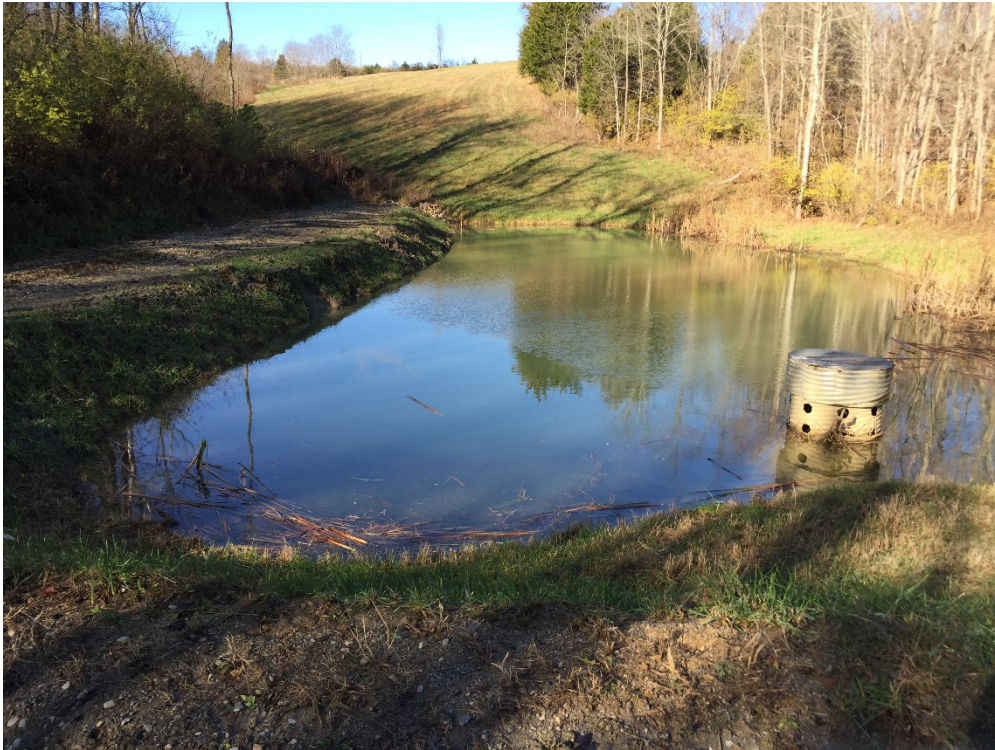
Photograph Number : IMG-7490
Description: Pond 2, looking west

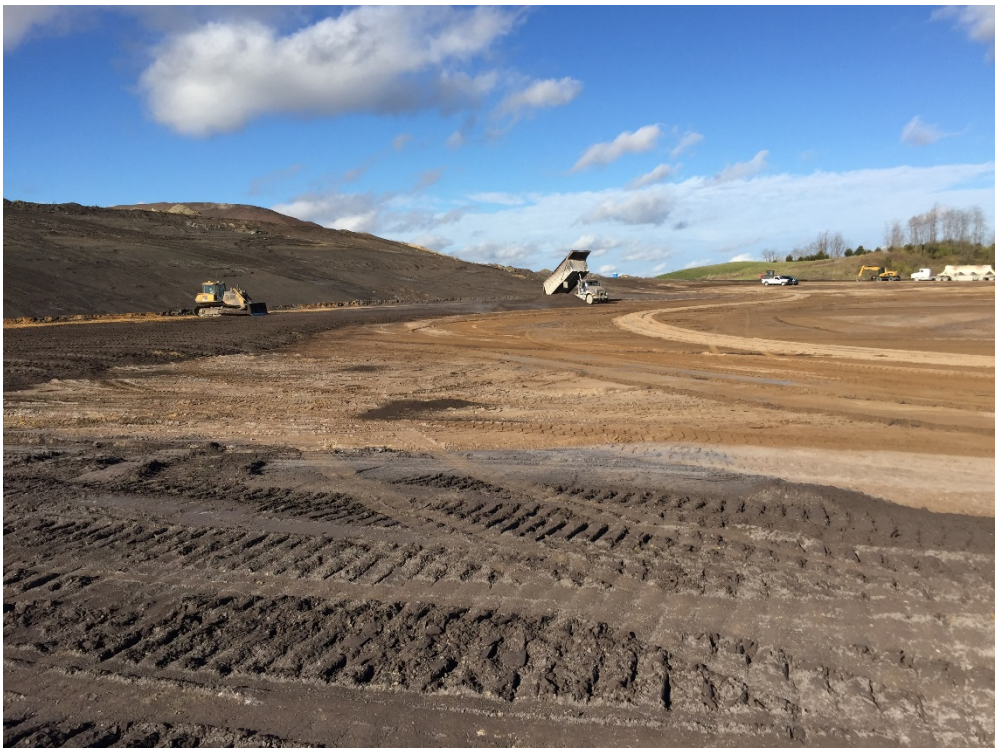
Photograph Number: IMG-7501
Description: Area C, Phase 2 working face/fill area, looking NW

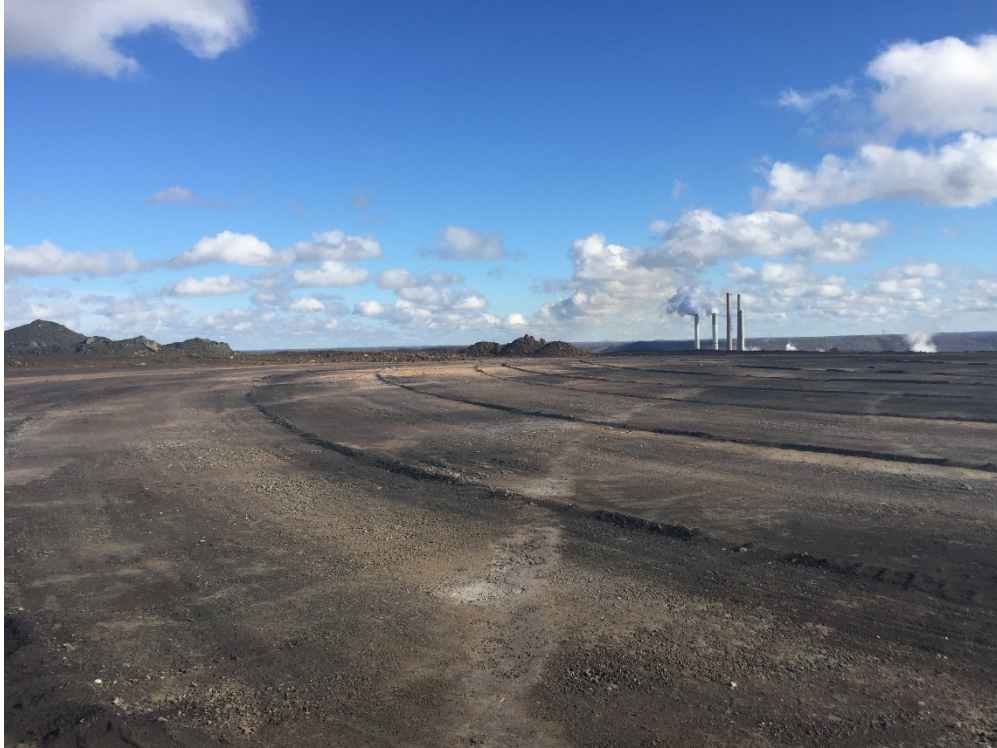
Photograph Number: IMG-7514
Description: Area C, Phase 1 working face/fill area, looking north

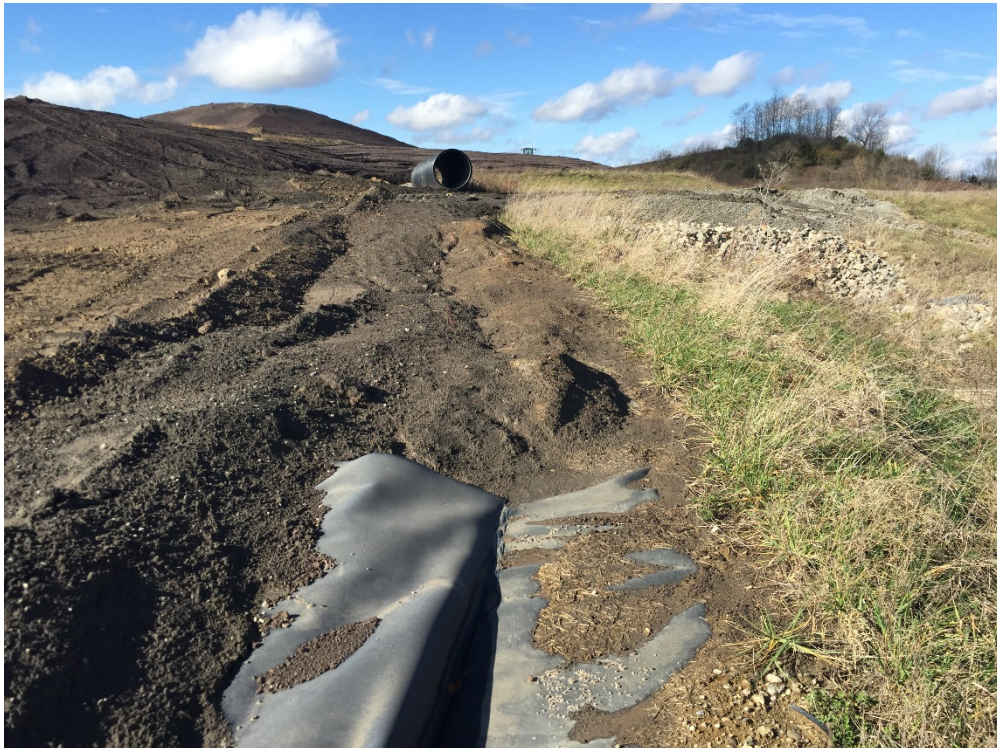
- 4) Minor erosion :
 - Areas of uncovered CCR (Photo IMG-7547),
 - Final cover constructed on the west and south slopes (Photo IMG-7542, 7543).
- 5) Small amount of CCR material outside the northern waste limits at the access point to Area C, Phase 2 (Photo IMG-7523).

Photograph Number: IMG-7523
Description: CCR outside the north waste limits of Area C, Phase 2

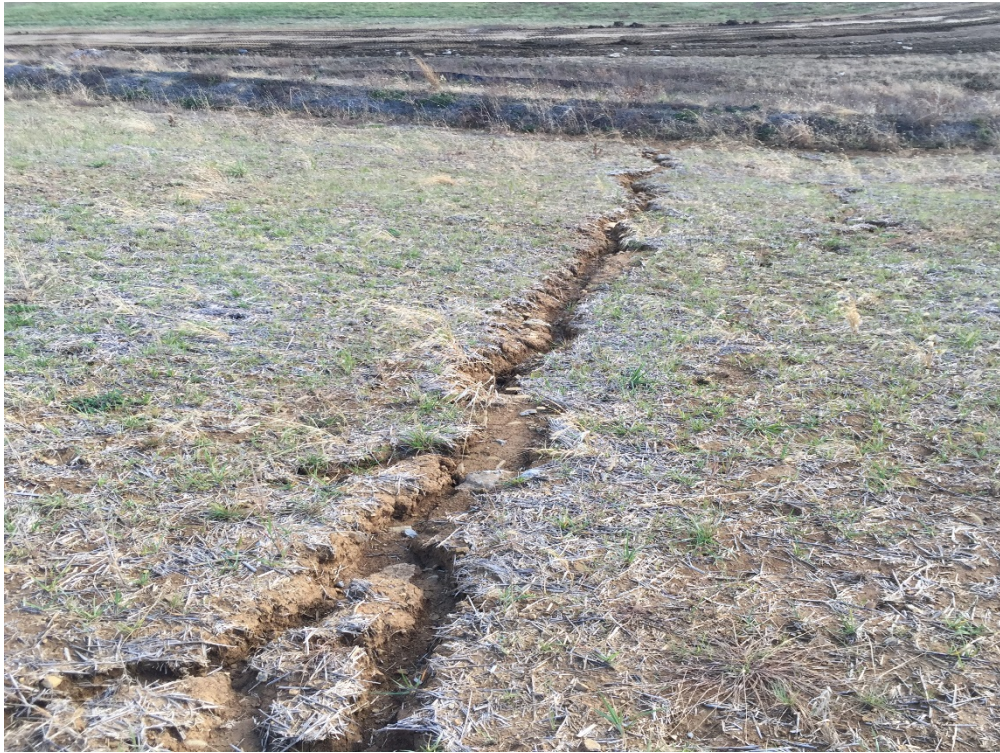
Photograph Number: IMG-7543
Description: Final cover erosion, west and south slopes

- Tall and woody vegetation should be mowed.
- Establish vegetation to deter erosion on final cover.
- For areas that exhibit erosion features including rills or gullies, appropriate measures should be employed to limit erosion.
- Ongoing monitoring of the north slough and future corrective actions for the south slough upslope of Pond 1 and the drainage ditch should be performed to eliminate potential impacts to the ditch, pond and associated structures.
- Monitoring of the landfill for leachate outbreaks and the leachate discharge point for signs of sediment should be done to confirm that the leachate system is not being clogged by the CCR.

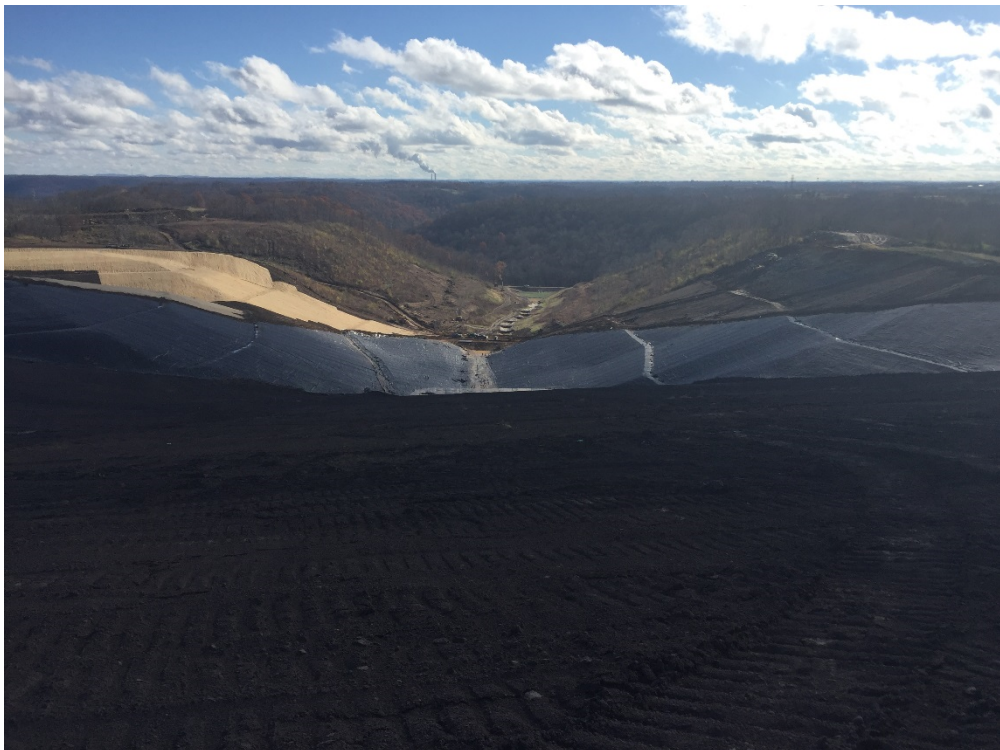
Photograph Number: IMG-7508
Description: Area C, Phase 3 construction and east slope of Area C, Phase 2, looking east

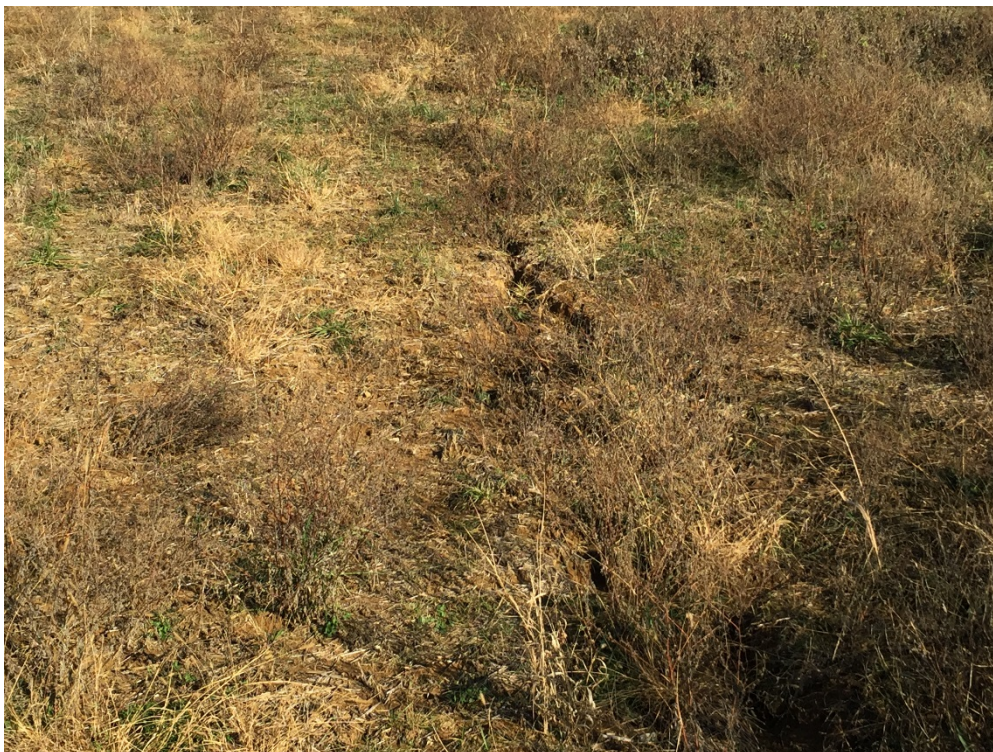
- 6) Excessively tall and woody vegetation observed on portions of the final cover (Photo IMG-7530).
- 7) Lack of vegetation on portions of the final cover (Photo IMG-7542).

Photograph Number: IMG-7530
Description: Final cover woody vegetation

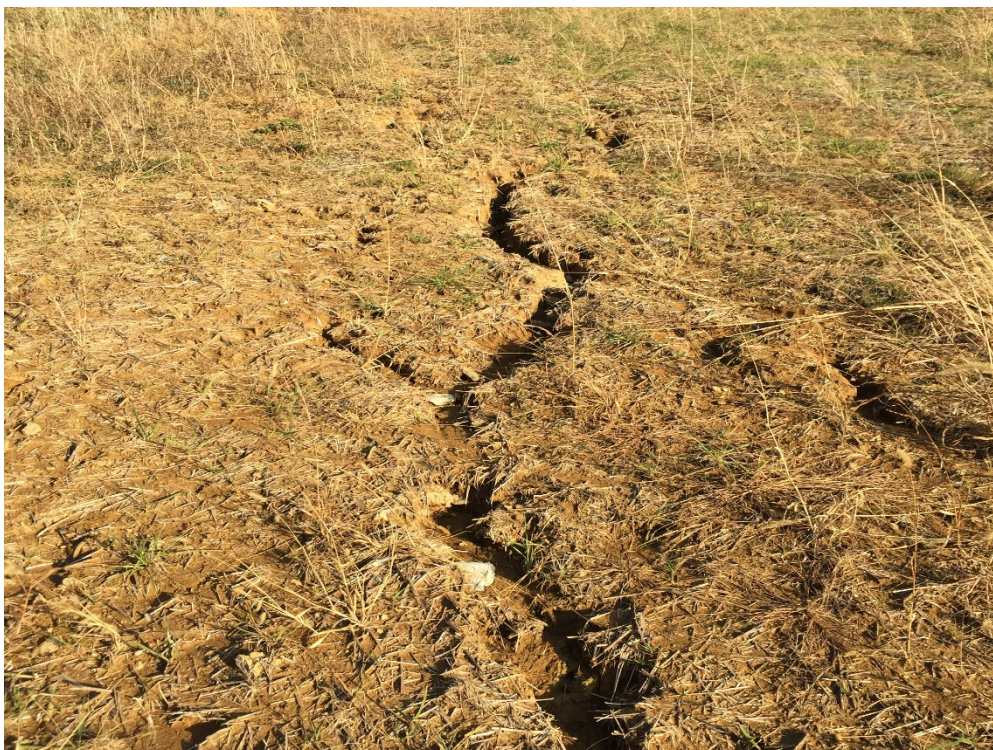
Photograph Number: IMG-7542
Description: Final cover lack of vegetation

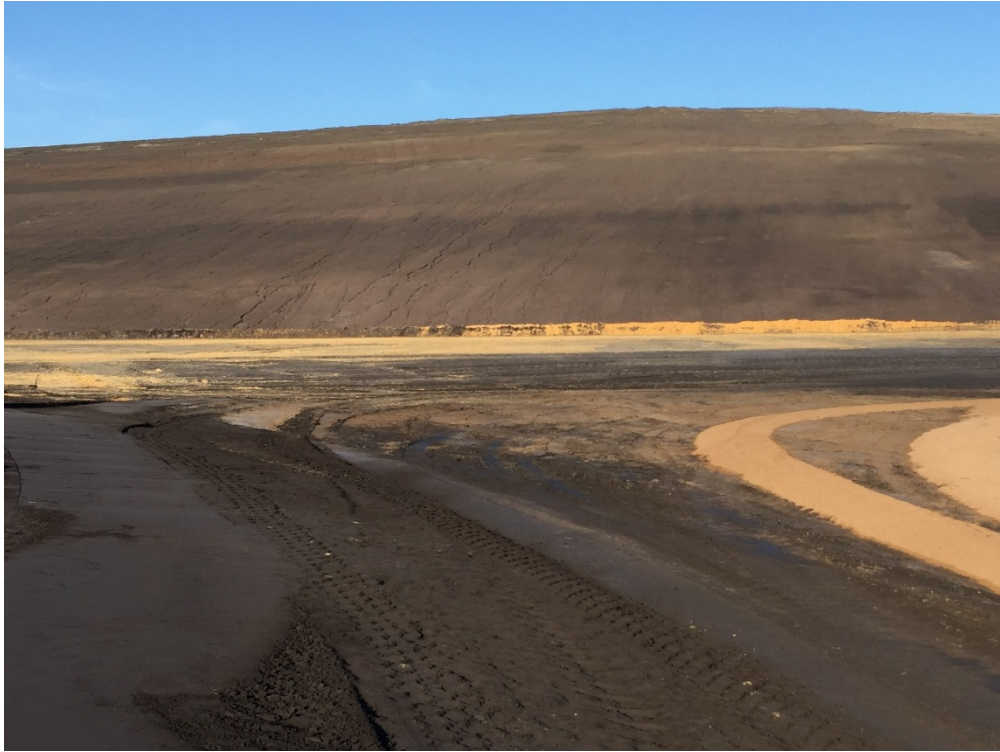
Photograph Number: IMG-7547

Description: Minor erosion on slope, uncovered CCR
