**2023 ANNUAL CCR LANDFILL INSPECTION**  
**SPURLOCK STATION POWER PLANT**

**EAST KENTUCKY POWER COOPERATIVE**  
**COAL COMBUSTION RESIDUAL RULE COMPLIANCE**

**JANUARY 6, 2024**

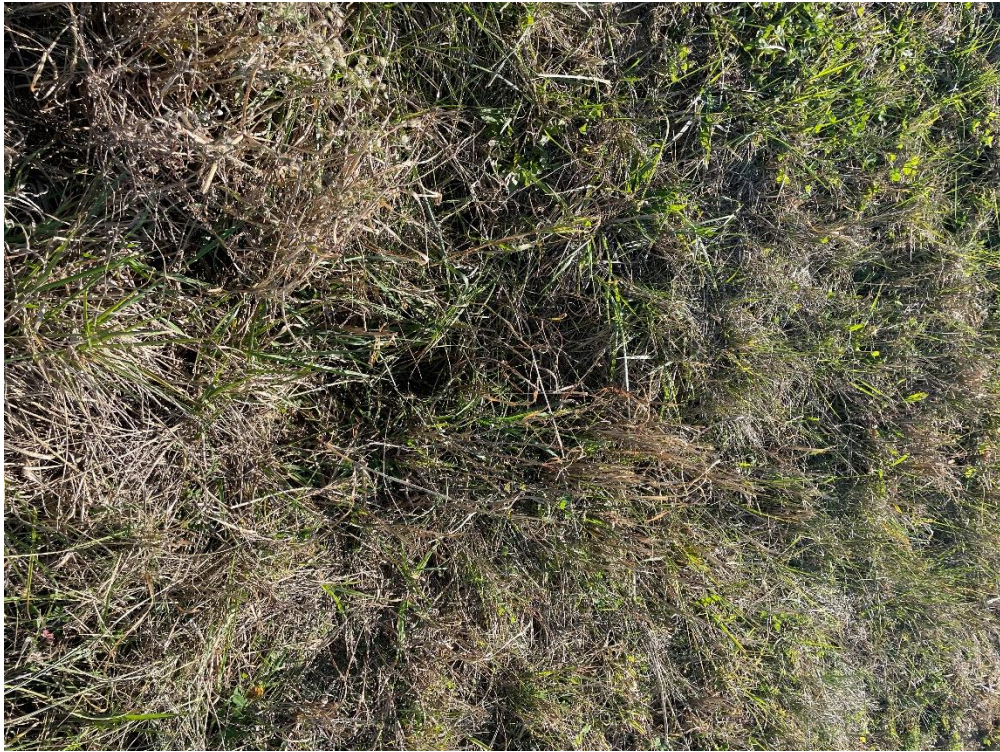
Photograph Number: IMG-2505

Description: West Final Cap Slope, north lower drainage berm –  
Abandoned animal burrow

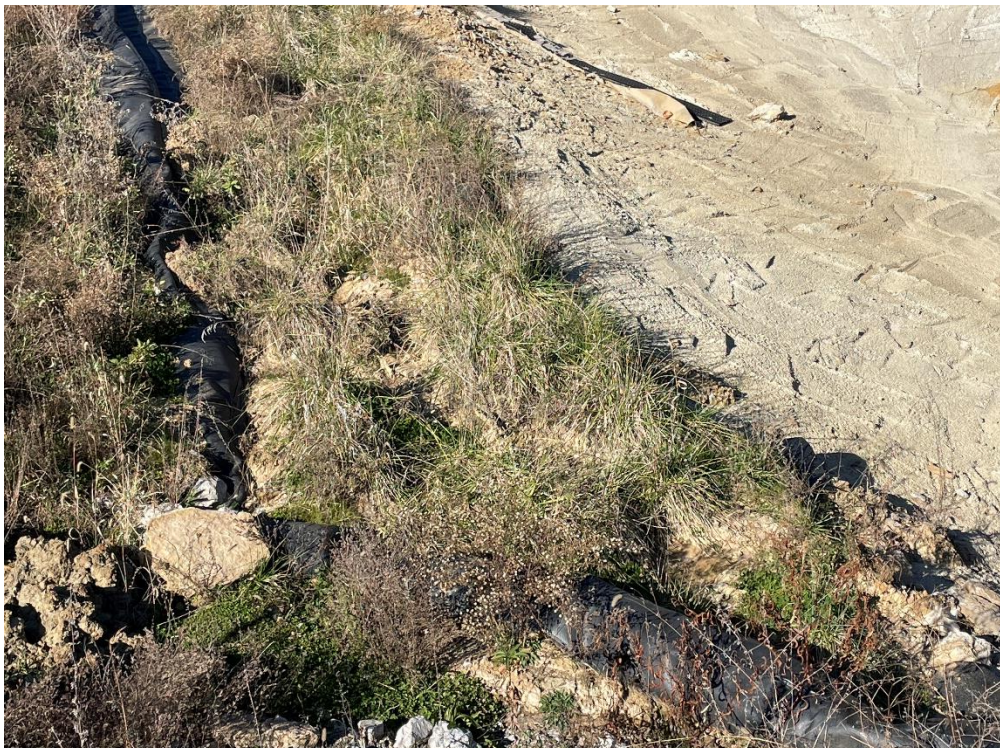
Photograph Number: IMG-2598

- 1) Monitor temporary cover soil repairs at the following locations:
  - a. Northeast slope of Area C Phase 4 and 5 (Photo IMG-2598, 2575).
  - b. East slope of Area C Phase 4 and 5 (Photo IMG-2578, 2579, 2588)
  - c. South slope of Area C Phase 5 (Photo IMG-2473).

Description: NE Area C phase 4 & 5– Erosion between anchor trench  
and ditch

- Repair erosion between the linear system and perimeter ditches where steep slopes occur on the Northeast limits of the landfill. Reestablish/apply erosion control materials/features to defer future erosion.
- Clean surface water perimeter ditches, ponds, and silt traps to provide for future sediment capture and proper operation of stormwater control structures.

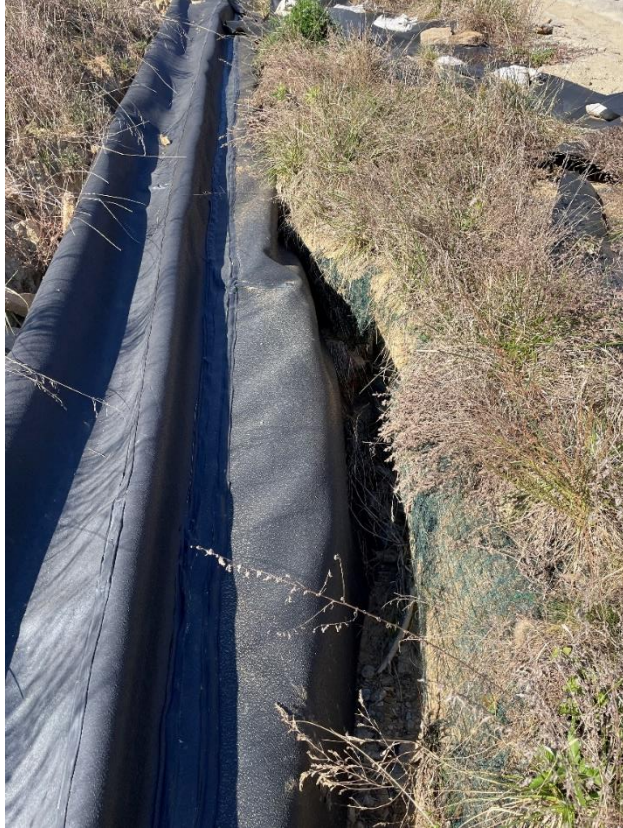
Photograph Number: IMG-2567

| Area | Condition Items | YES | NO | MONITOR<br>** | Inspector Observations and Photo<br>Number(s) | |
|---|---|---|---|---|---|--|
| | Inadequate Slope Protection | <input type="checkbox"/> | <input checked="" type="checkbox"/> | <input type="checkbox"/> | Area C Phase 4 anchor trench erosion, NE slope (IMG-2566, 2567). | |

Description: NE Area C phase 4 – Anchor Trench erosion

| | | YES | NO |
|---|---|---|---|
| 3. | <p>Per observation of the above items, are there remedial actions that need to take place. If yes, discuss below and attach photos:</p> <p><u>Repair soil cover and anchor trench erosion at the NE toe of slope in Area C Phase 4, east and south slopes of Area C Phase 4 &amp; 5. Repair animal burrow hole on the west final cap. Remove woody vegetation: final cap north downdrain, Area C Phase 3 &amp; 5 liner tie-in/anchor trench, Area C Phase 3 entrance road culvert pipe outlet, ditches - NW final cap and south Phase 3, Pond 1 and 2A edges and spillways and SE waste limit of Phase 4 &amp; 5. Remove sediment from the road ditch to Area C Phase 1, Area C Phase 3 east toe ditch, Pond 1 (including upper chamber &amp; sed. trap).</u></p> | <input checked="" type="checkbox"/> | <input type="checkbox"/> |

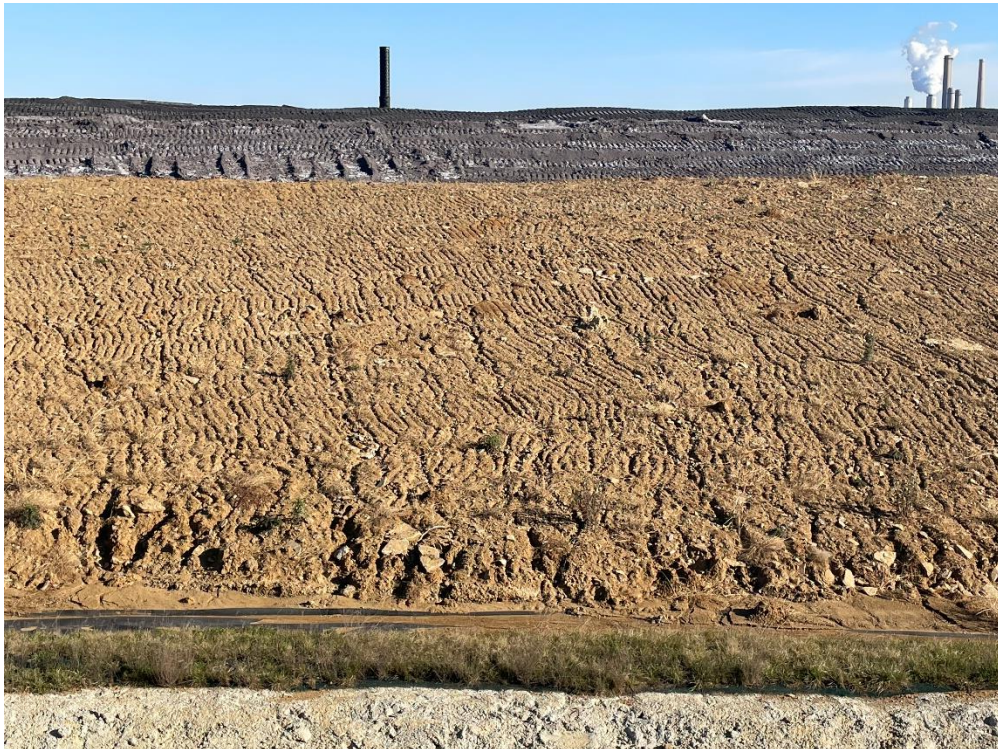
Photograph Number: IMG-2473

Description: South side of Area C Phase 5 – Monitor erosion & veg. growth

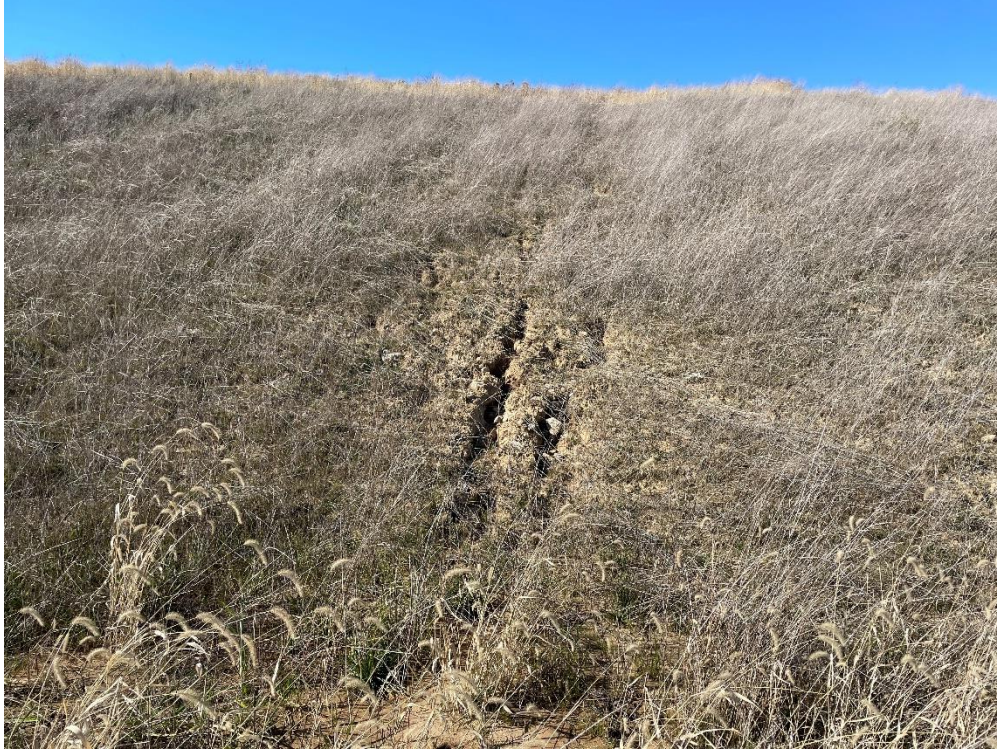
Photograph Number: IMG-2578

Description: Phase 4 & 5 east slope– Monitor erosion & veg. growth

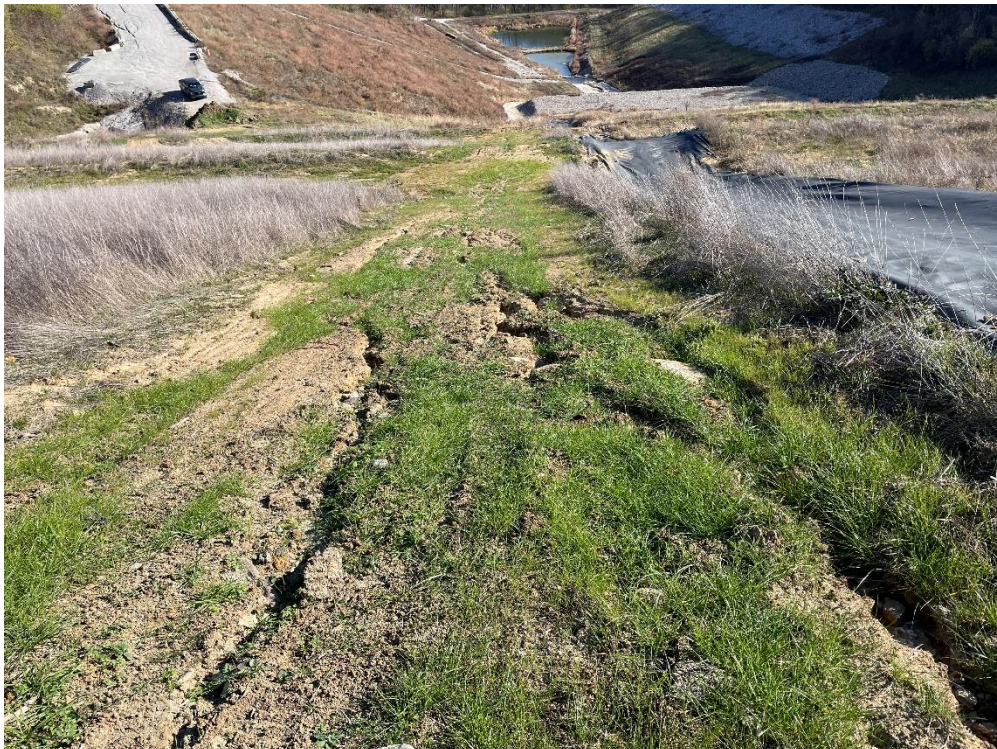
Photograph Number: IMG-2579

Description: Phase 4 & 5 east slope – Monitor erosion & veg. growth

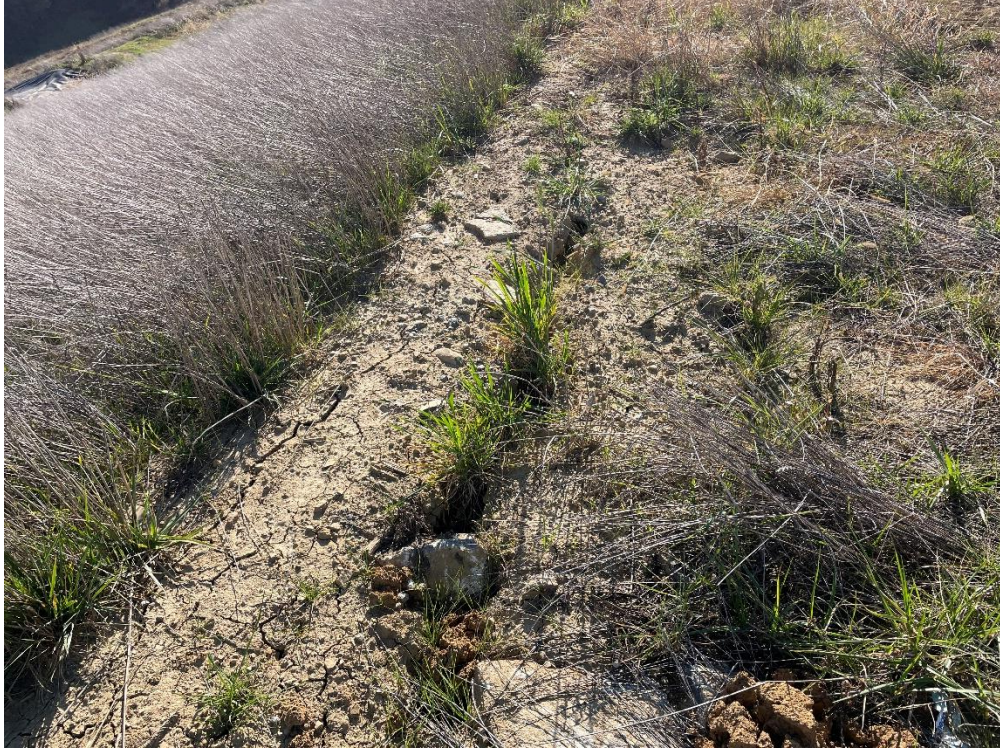
Photograph Number: IMG-2590

- 2) Temporary soil cover cracking on the upper bench of Area C Phase 4 & 5's east slope. During the annual inspection, cracks still visible appear to have stabilized. (Photo IMG-2590).
- 3) Seed, fertilize, and mulch bare temporary soil cover placed on Area C Phase 4 and 5's South and East slopes (Photo IMG-2583, 2574).

| Area | Condition Items | YES | NO | MONITOR<br>** | Inspector Observations and Photo<br>Number(s) |
|---|---|---|---|---|--|
| Landfill | Surface Cracking | <input checked="" type="checkbox"/> | <input type="checkbox"/> | <input checked="" type="checkbox"/> | Temp. soil cover cracking: Cracks on Area C Phase 4 & 5 upper east bench (IMG-2590). |

Description: Area C Phase 4 & 5 east slope – Monitor temp. cover  
soil cracking

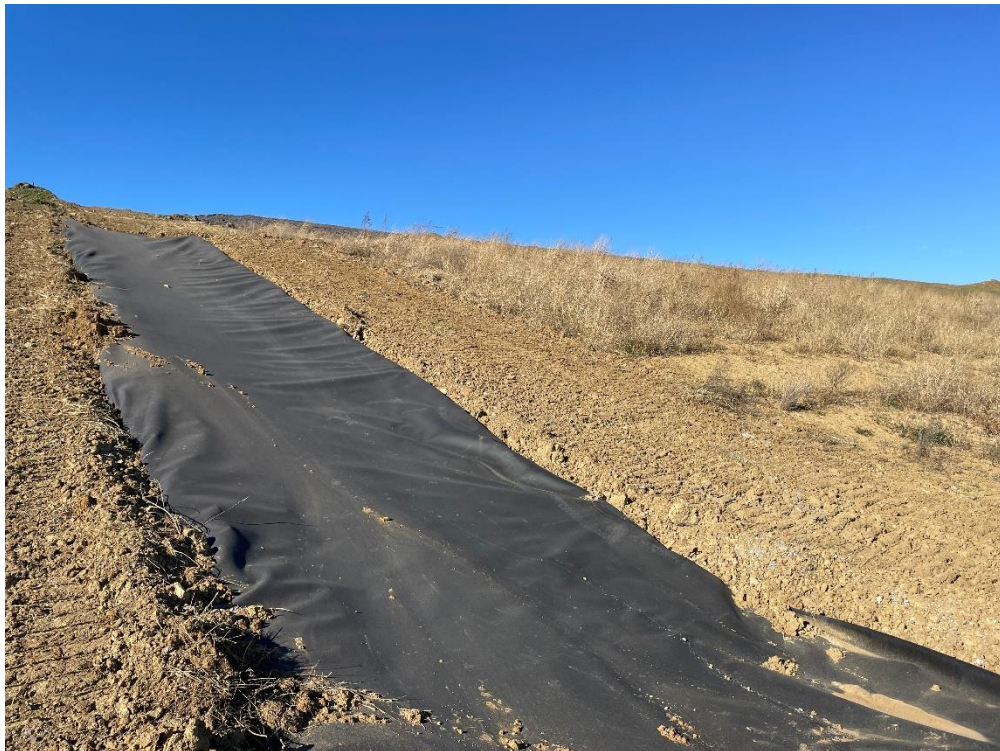
Photograph Number: IMG-2583

Description: Area C Phase 4 & 5 – Seed and fertilize bare soil cover

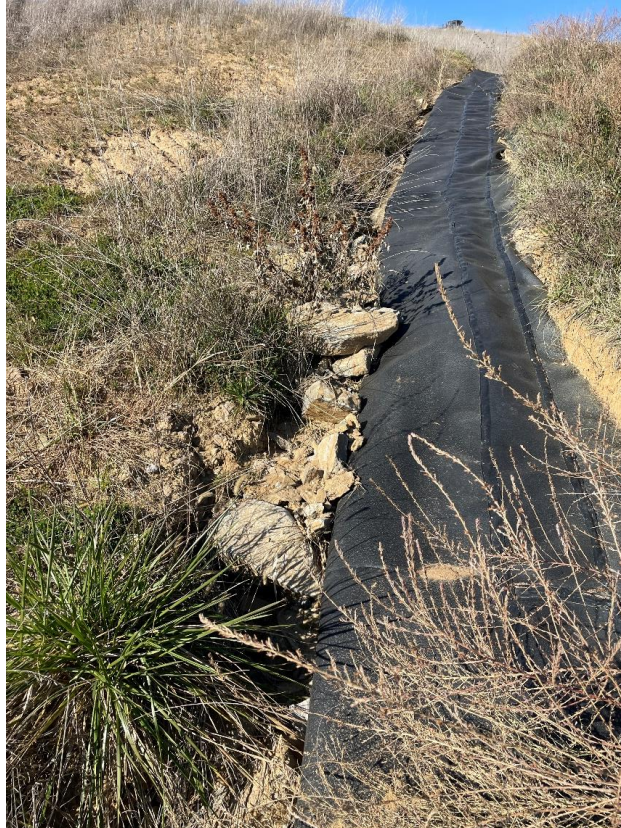
Photograph Number: IMG-2570

Description: Area C Phase 5 south slope – Rocks on liner system

- Area C Phase 4 and 5 - remove rocks from the south and northeast toe of slope, near the landfill liner interface to avoid potential geosynthetics damage.
- Remove woody vegetation in downdrain structures and growing in CCR at or near the liner system. Controlling woody vegetation growth in ditches, downdrains and pond riprap protection may be performed by: applying herbicides, cutting or direct removal. Woody vegetation growing in CCR materials at or near the liner system should be eliminated by direct removal.
- Fill in holes/voids created by abandoned animal burrow with soil and establish vegetation to deter surface water infiltration and erosion.
- Backfill anchor trench with compacted clay soils or other acceptable structural materials and install erosion protection that will deter future erosion from surface water run-on/run-off.

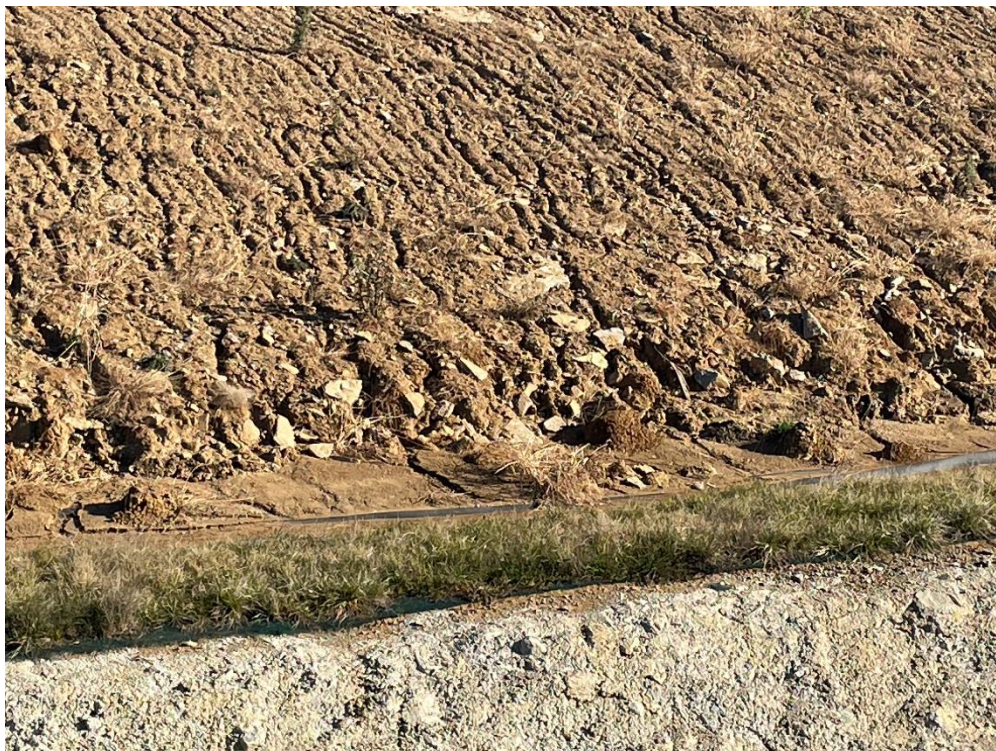
Photograph Number: IMG-2475

Description: Area C Phase 5 south slope – Rocks on liner system

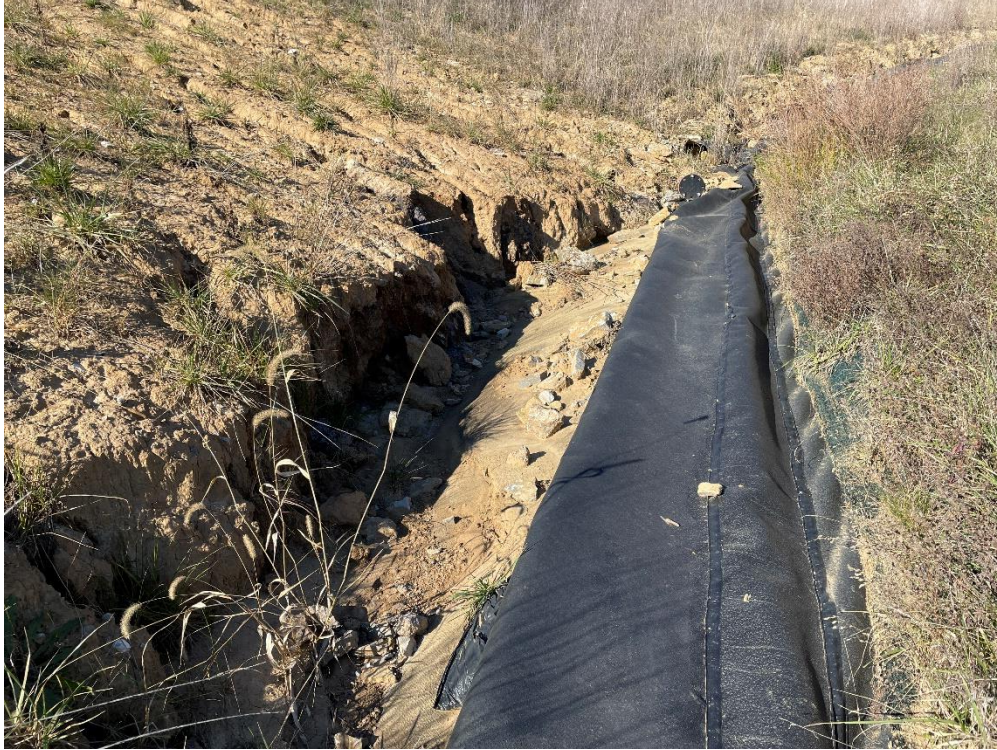
Photograph Number: IMG-2574

Description: Area C Phase 4 & 5, NE – Rocks on liner system

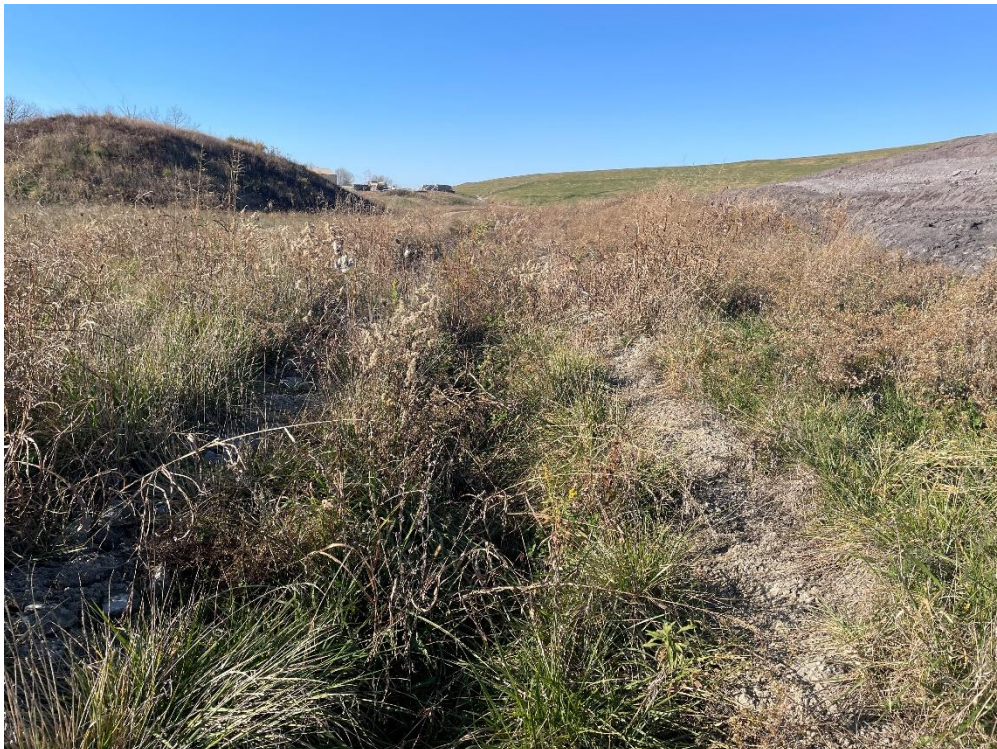
Photograph Number: IMG-2476

Description: Area C Phase 3 South ditch – Woody vegetation growth

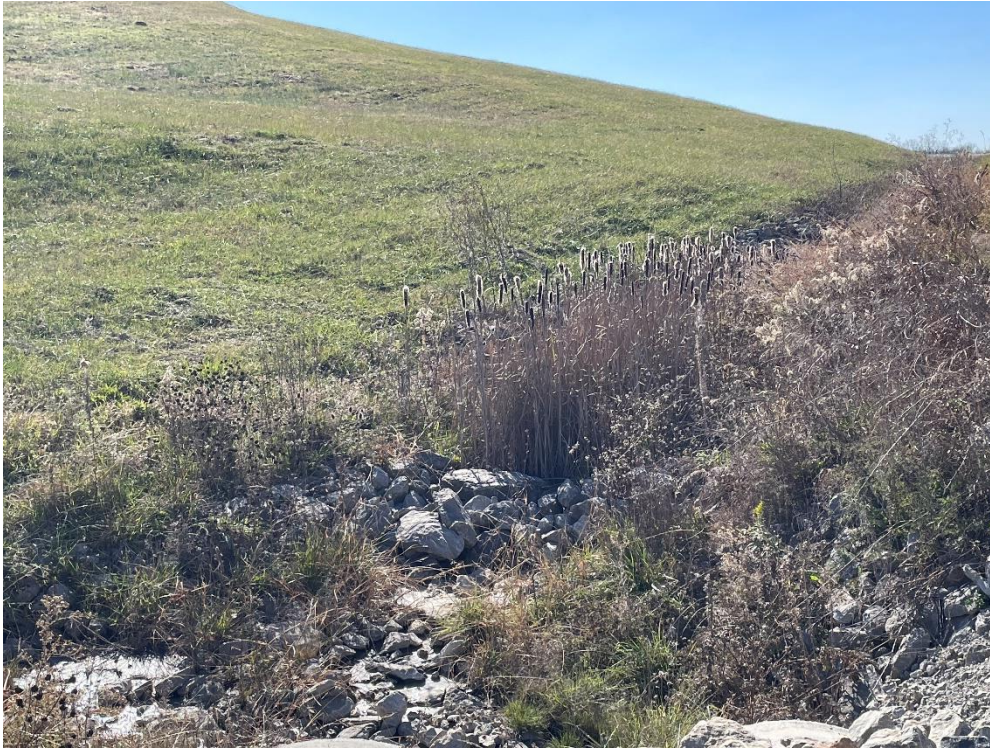
Photograph Number: IMG-2541  
Description: West final cap, NW ditch – Woody vegetation growth

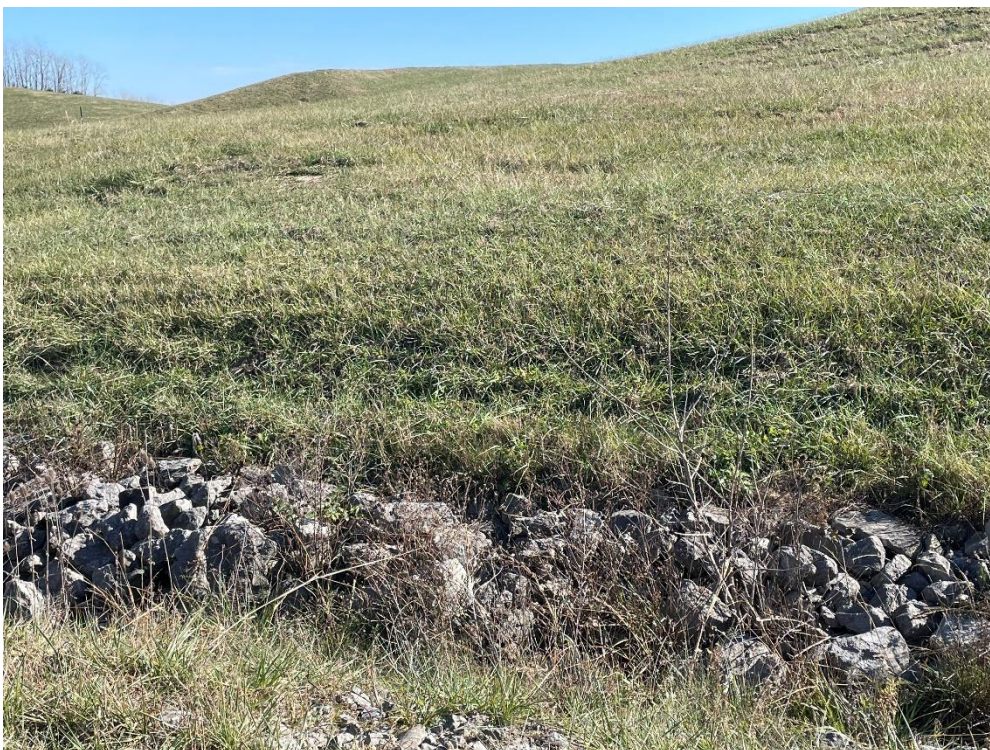
Photograph Number: IMG-2542  
Description: West final cap, NW – Remove woody vegetation growth

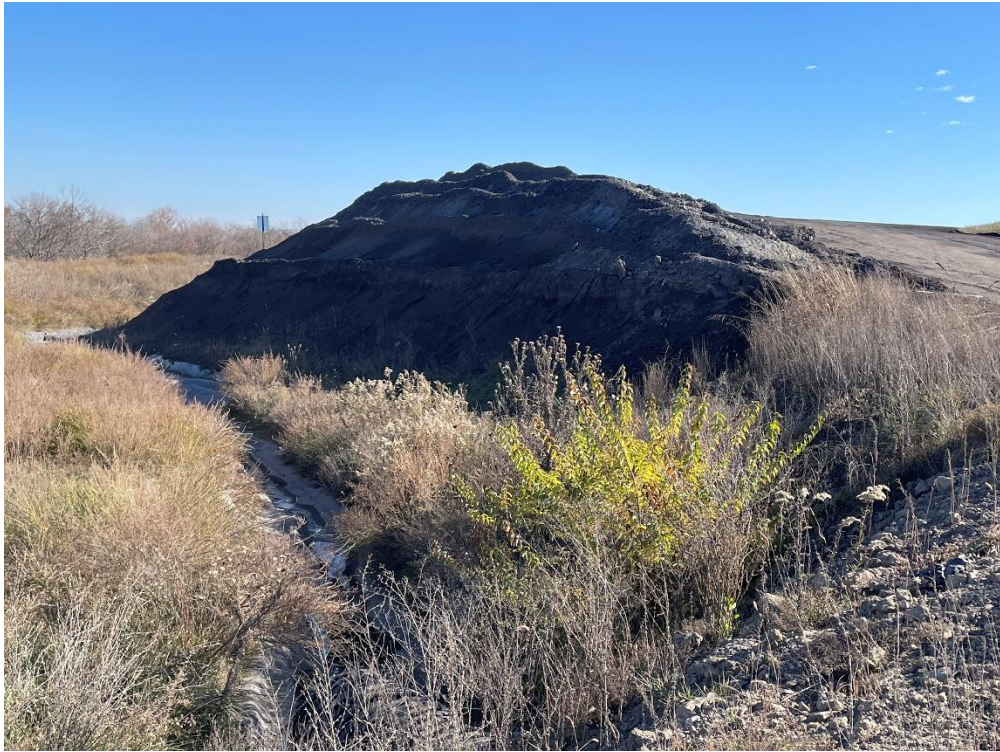
Photograph Number: IMG-2557

Description: Area C Phase 3 entrance road– Woody vegetation growth at culvert outlet

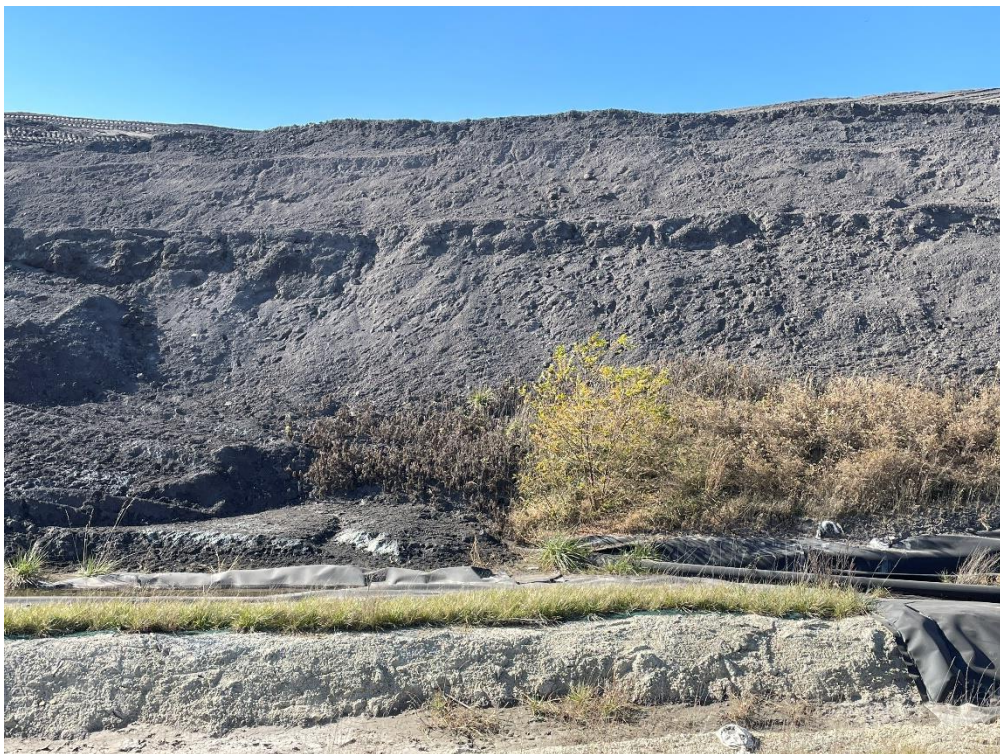
Photograph Number: IMG-2558

Description: Area C Phase 5 tie-in, north slope – Woody vegetation growth

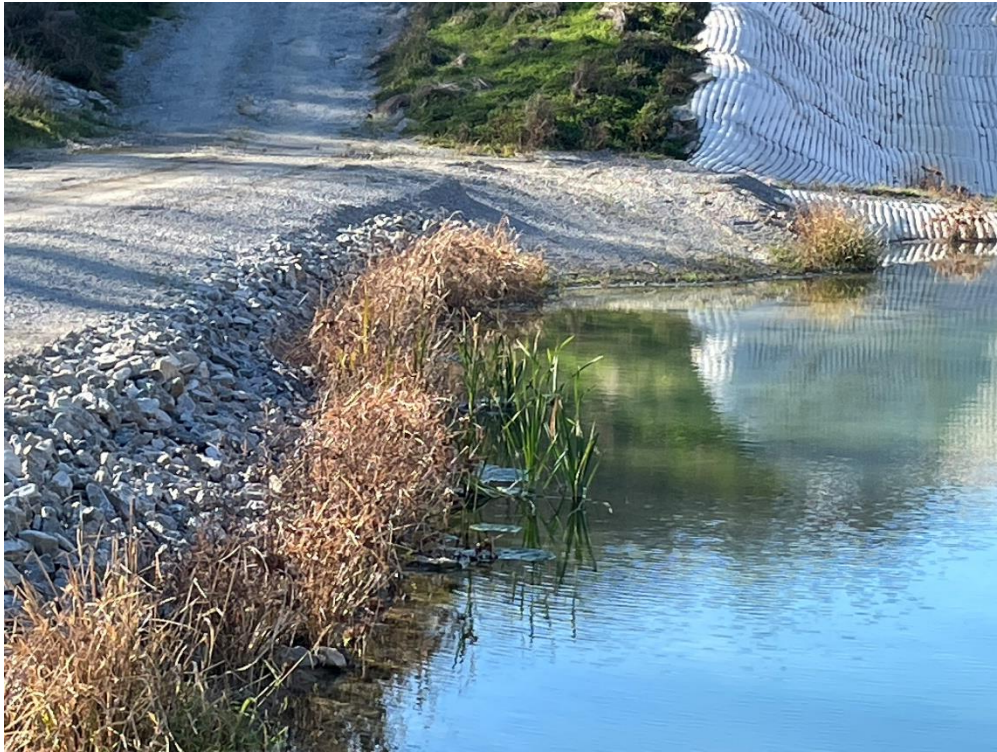
Photograph Number: IMG-2601  
Description: Pond 2A – Woody vegetation growth

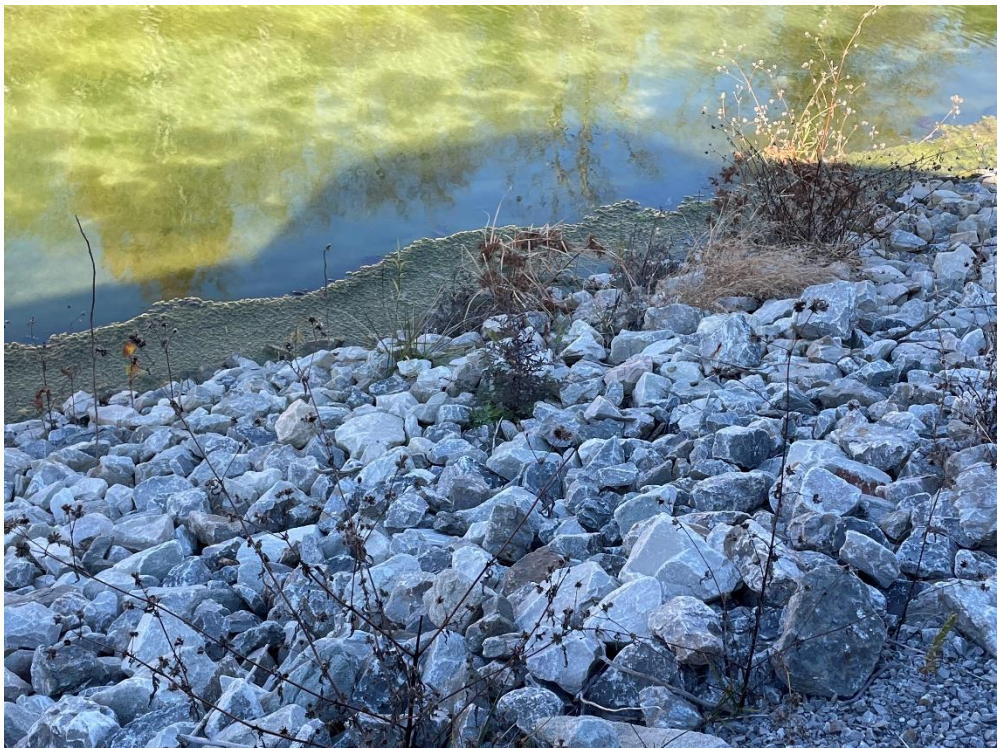
Photograph Number: IMG-2604  
Description: Pond 2A – Woody vegetation growth

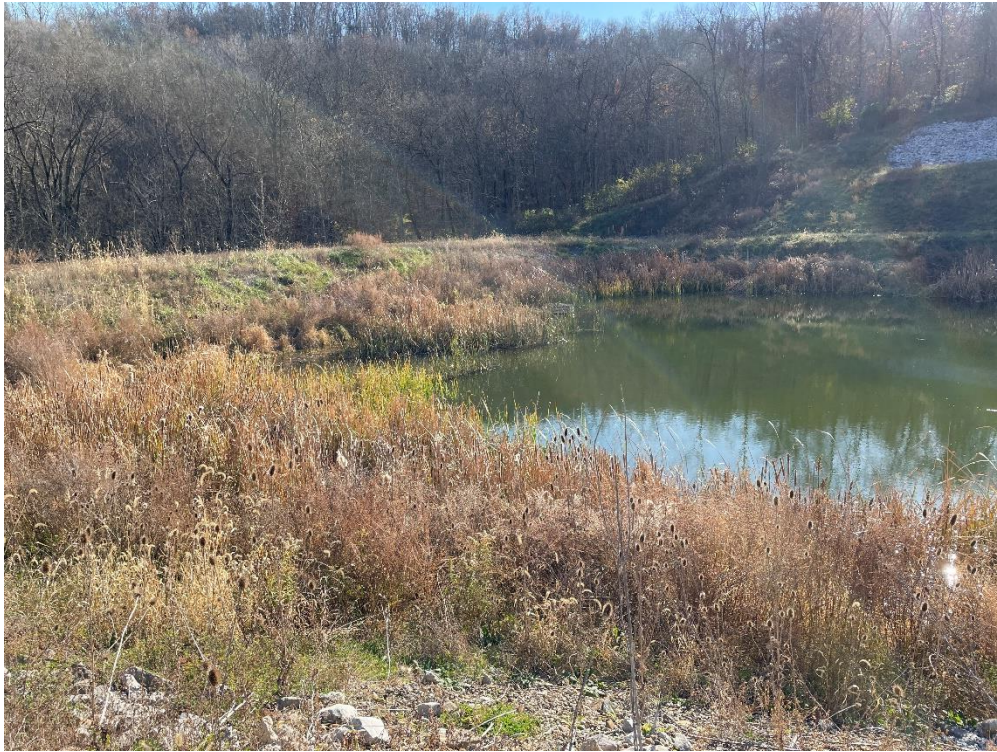
Photograph Number: IMG-2614  
Description: Pond 1– Woody vegetation growth

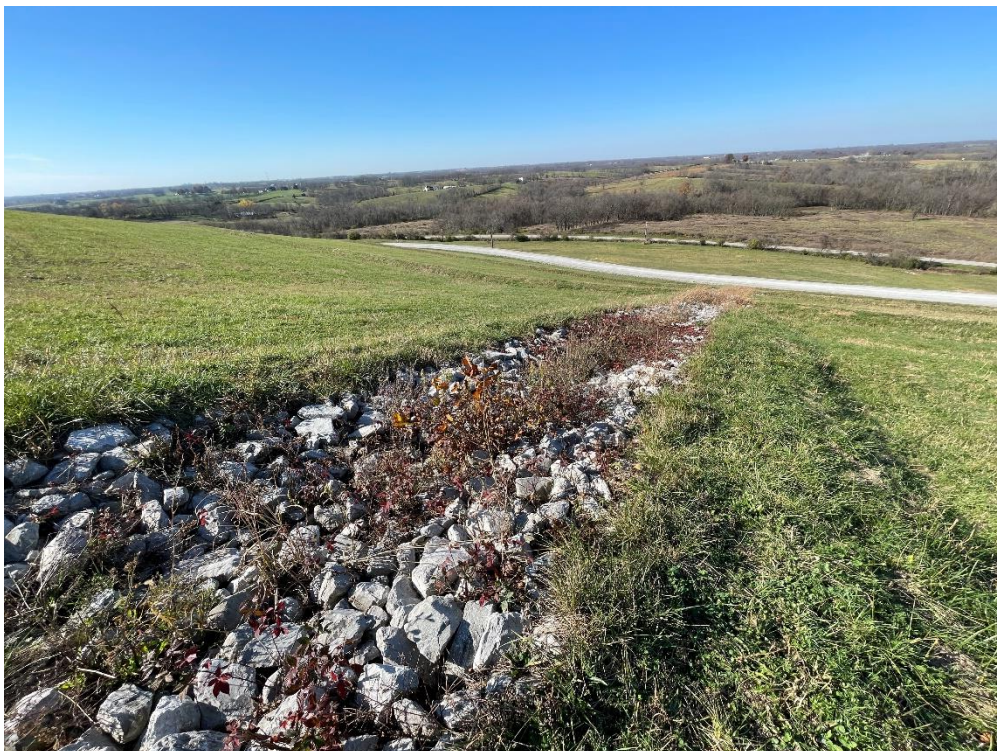
Photograph Number: IMG-2494  
Description: West Final Cap, north downdrain – Woody vegetation growth

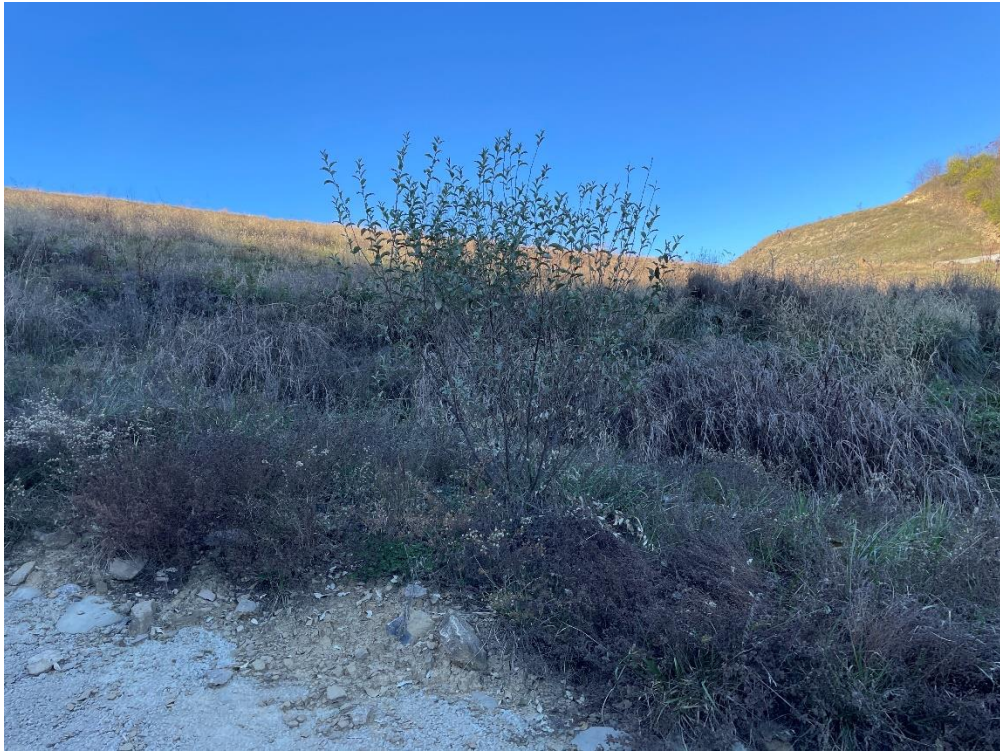
Photograph Number: IMG-2622  
Description: Area C Phase 4, SE – Woody vegetation growth

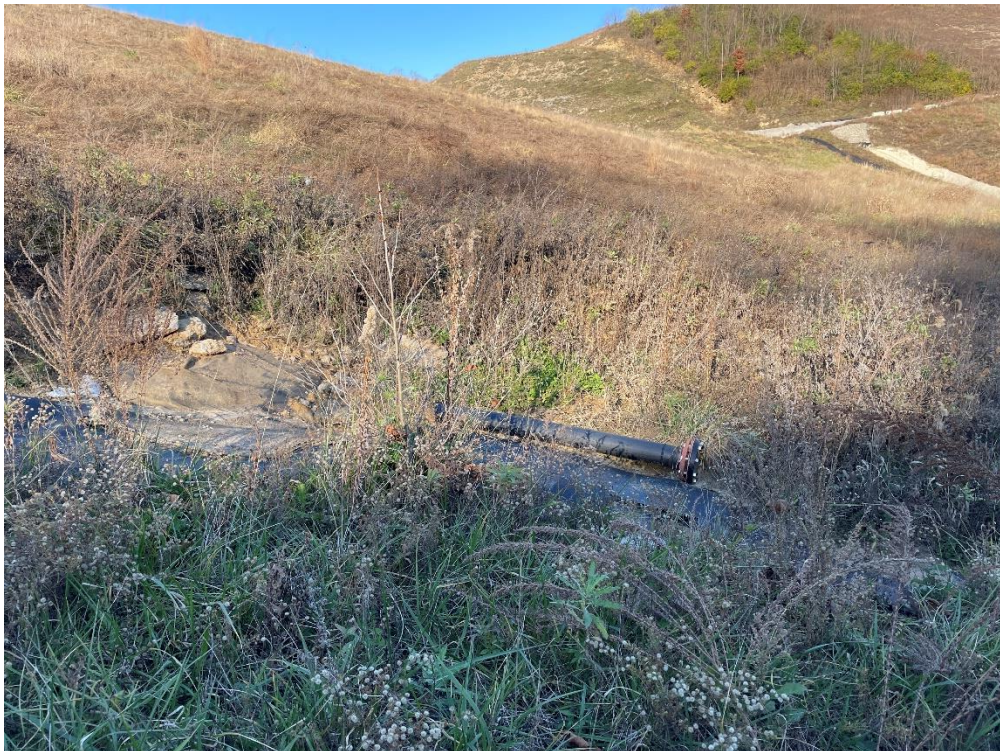
Photograph Number: IMG-2623  
Description: Area C Phase 4, SE – Woody vegetation growth

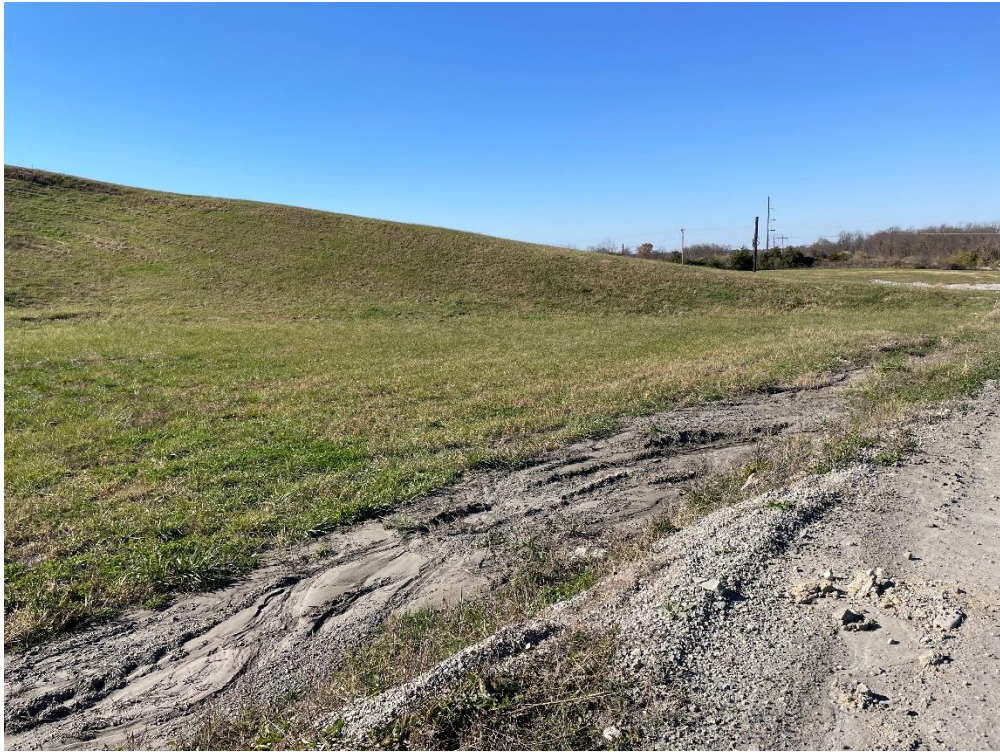
Photograph Number: IMG-2540

Description: South Ditch– sediment accumulation road to Area C  
Phase 1, South Ditch

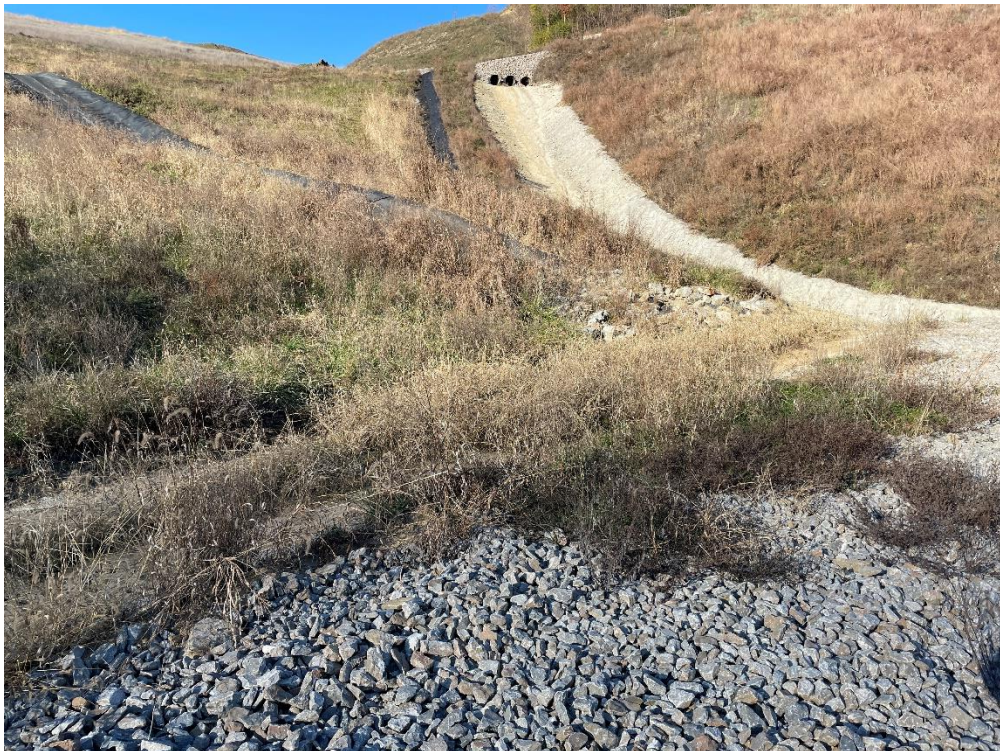
Photograph Number: IMG-2621

Description: Area C Phase 4, east toe ditch – Remove sediment and  
veg. growth

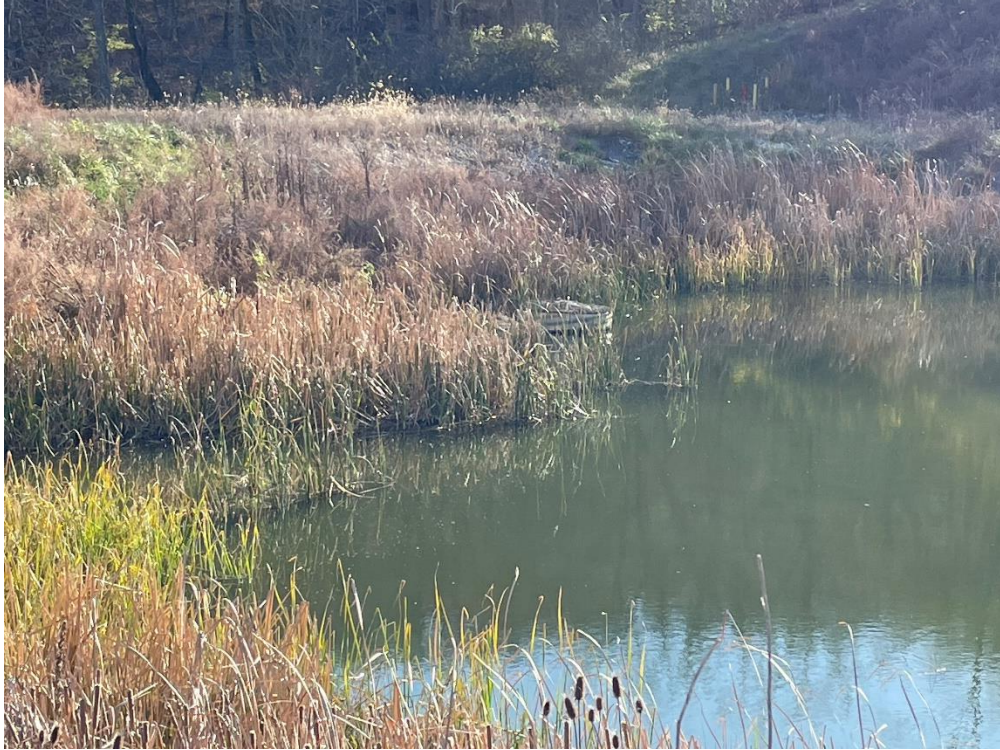
Photograph Number: IMG-2615  
Description: Pond 1– Clean out sediment

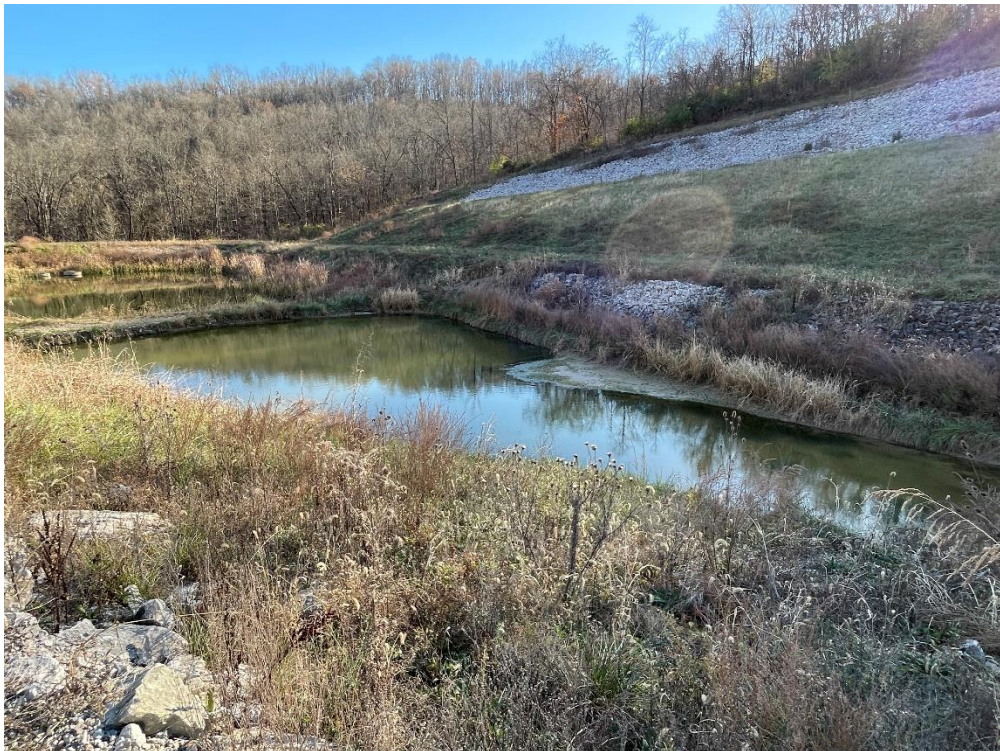
Photograph Number: IMG-2617  
Description: Pond 1 Upper chamber – Clean out sediment

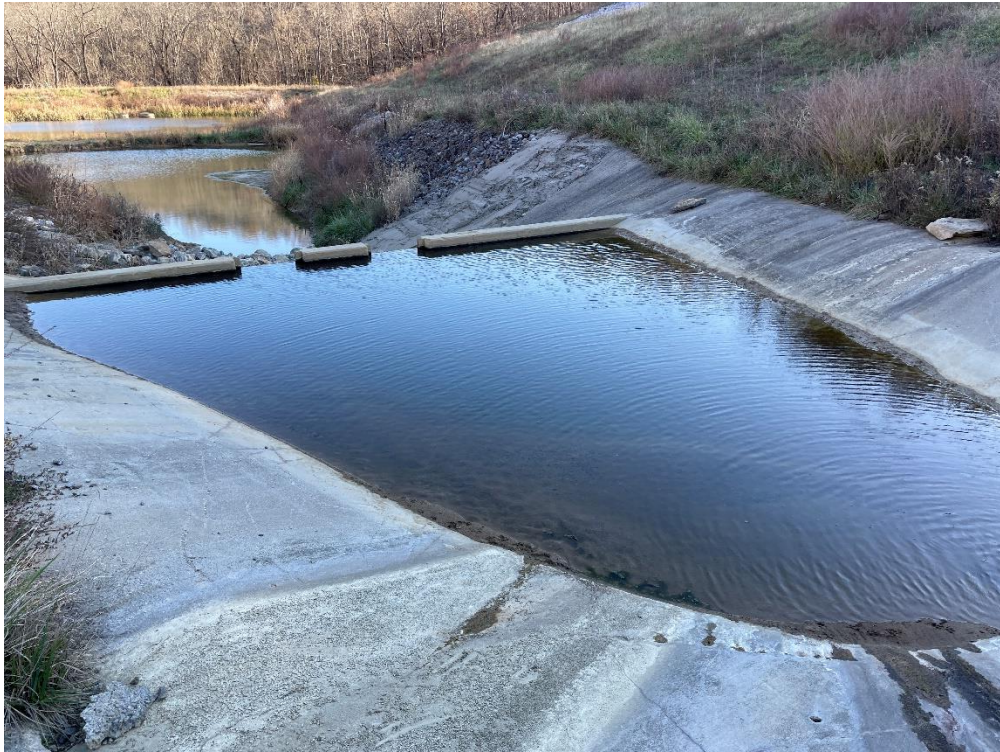
Photograph Number: IMG-2618  
Description: Pond 1 – Clean out concrete sediment trap

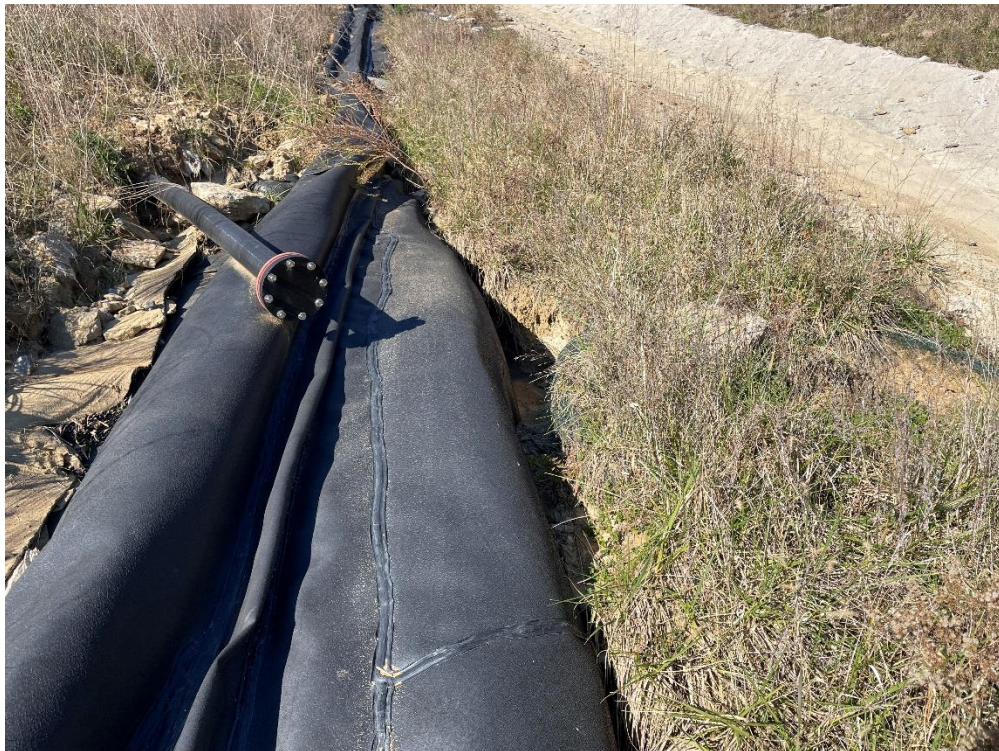
Photograph Number: IMG-2566  
Description: NE Area C phase 4 – Anchor Trench erosion

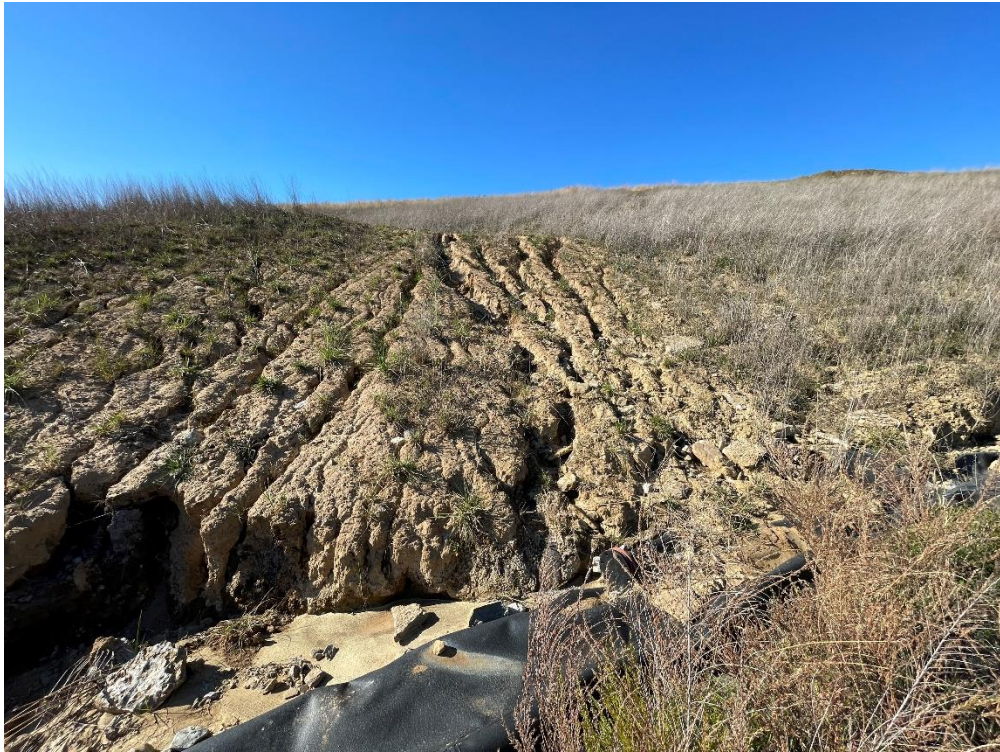
Photograph Number: IMG-2575

Description: NE slope Area C Phase 5 – Monitor erosion & veg. growth
