**2023 ANNUAL CCR LANDFILL INSPECTION**  
**SPURLOCK STATION POWER PLANT**

**EAST KENTUCKY POWER COOPERATIVE**  
**COAL COMBUSTION RESIDUAL RULE COMPLIANCE**

**JANUARY 6, 2024**

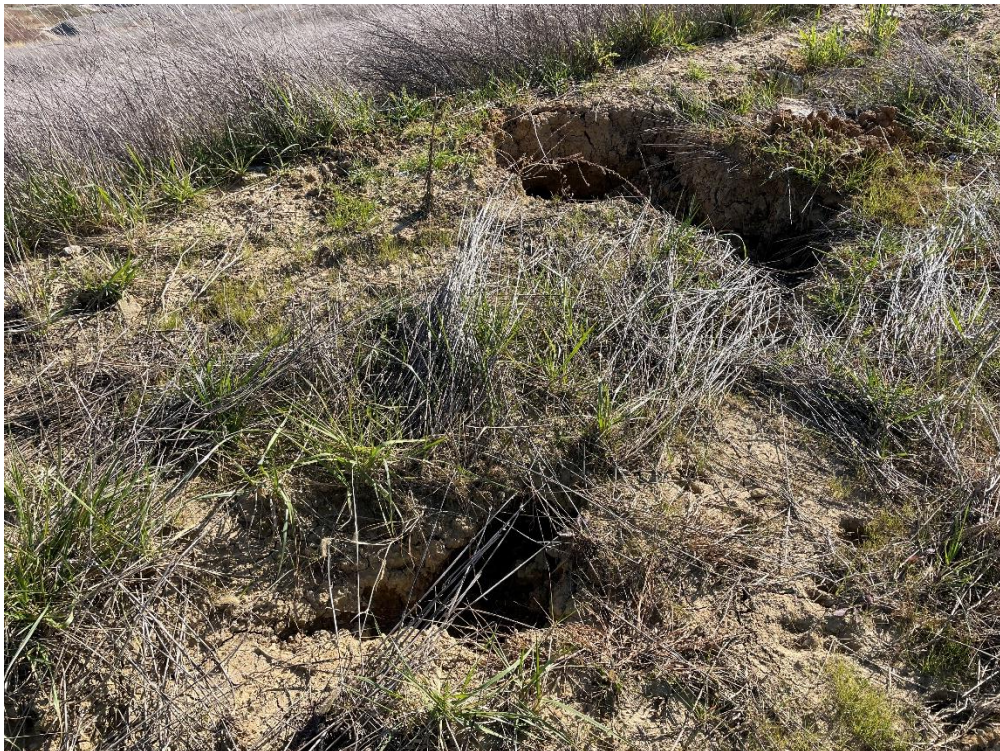
Photograph Number: IMG-2588

- 1) Monitor temporary cover soil repairs at the following locations:
  - a. Northeast slope of Area C Phase 4 and 5 (Photo IMG-2598, 2575).
  - b. East slope of Area C Phase 4 and 5 (Photo IMG-2578, 2579, 2588)
  - c. South slope of Area C Phase 5 (Photo IMG-2473).

Description: east slope of Area C Phase 4 and 5 – Monitor erosion & veg. growth
