**ANNUAL CCR LANDFILL INSPECTION
SPURLOCK STATION POWER PLANT**

**EAST KENTUCKY POWER COOPERATIVE
COAL COMBUSTION RESIDUAL RULE COMPLIANCE**

JANUARY 2017

REV. 1 (3/6/2017)

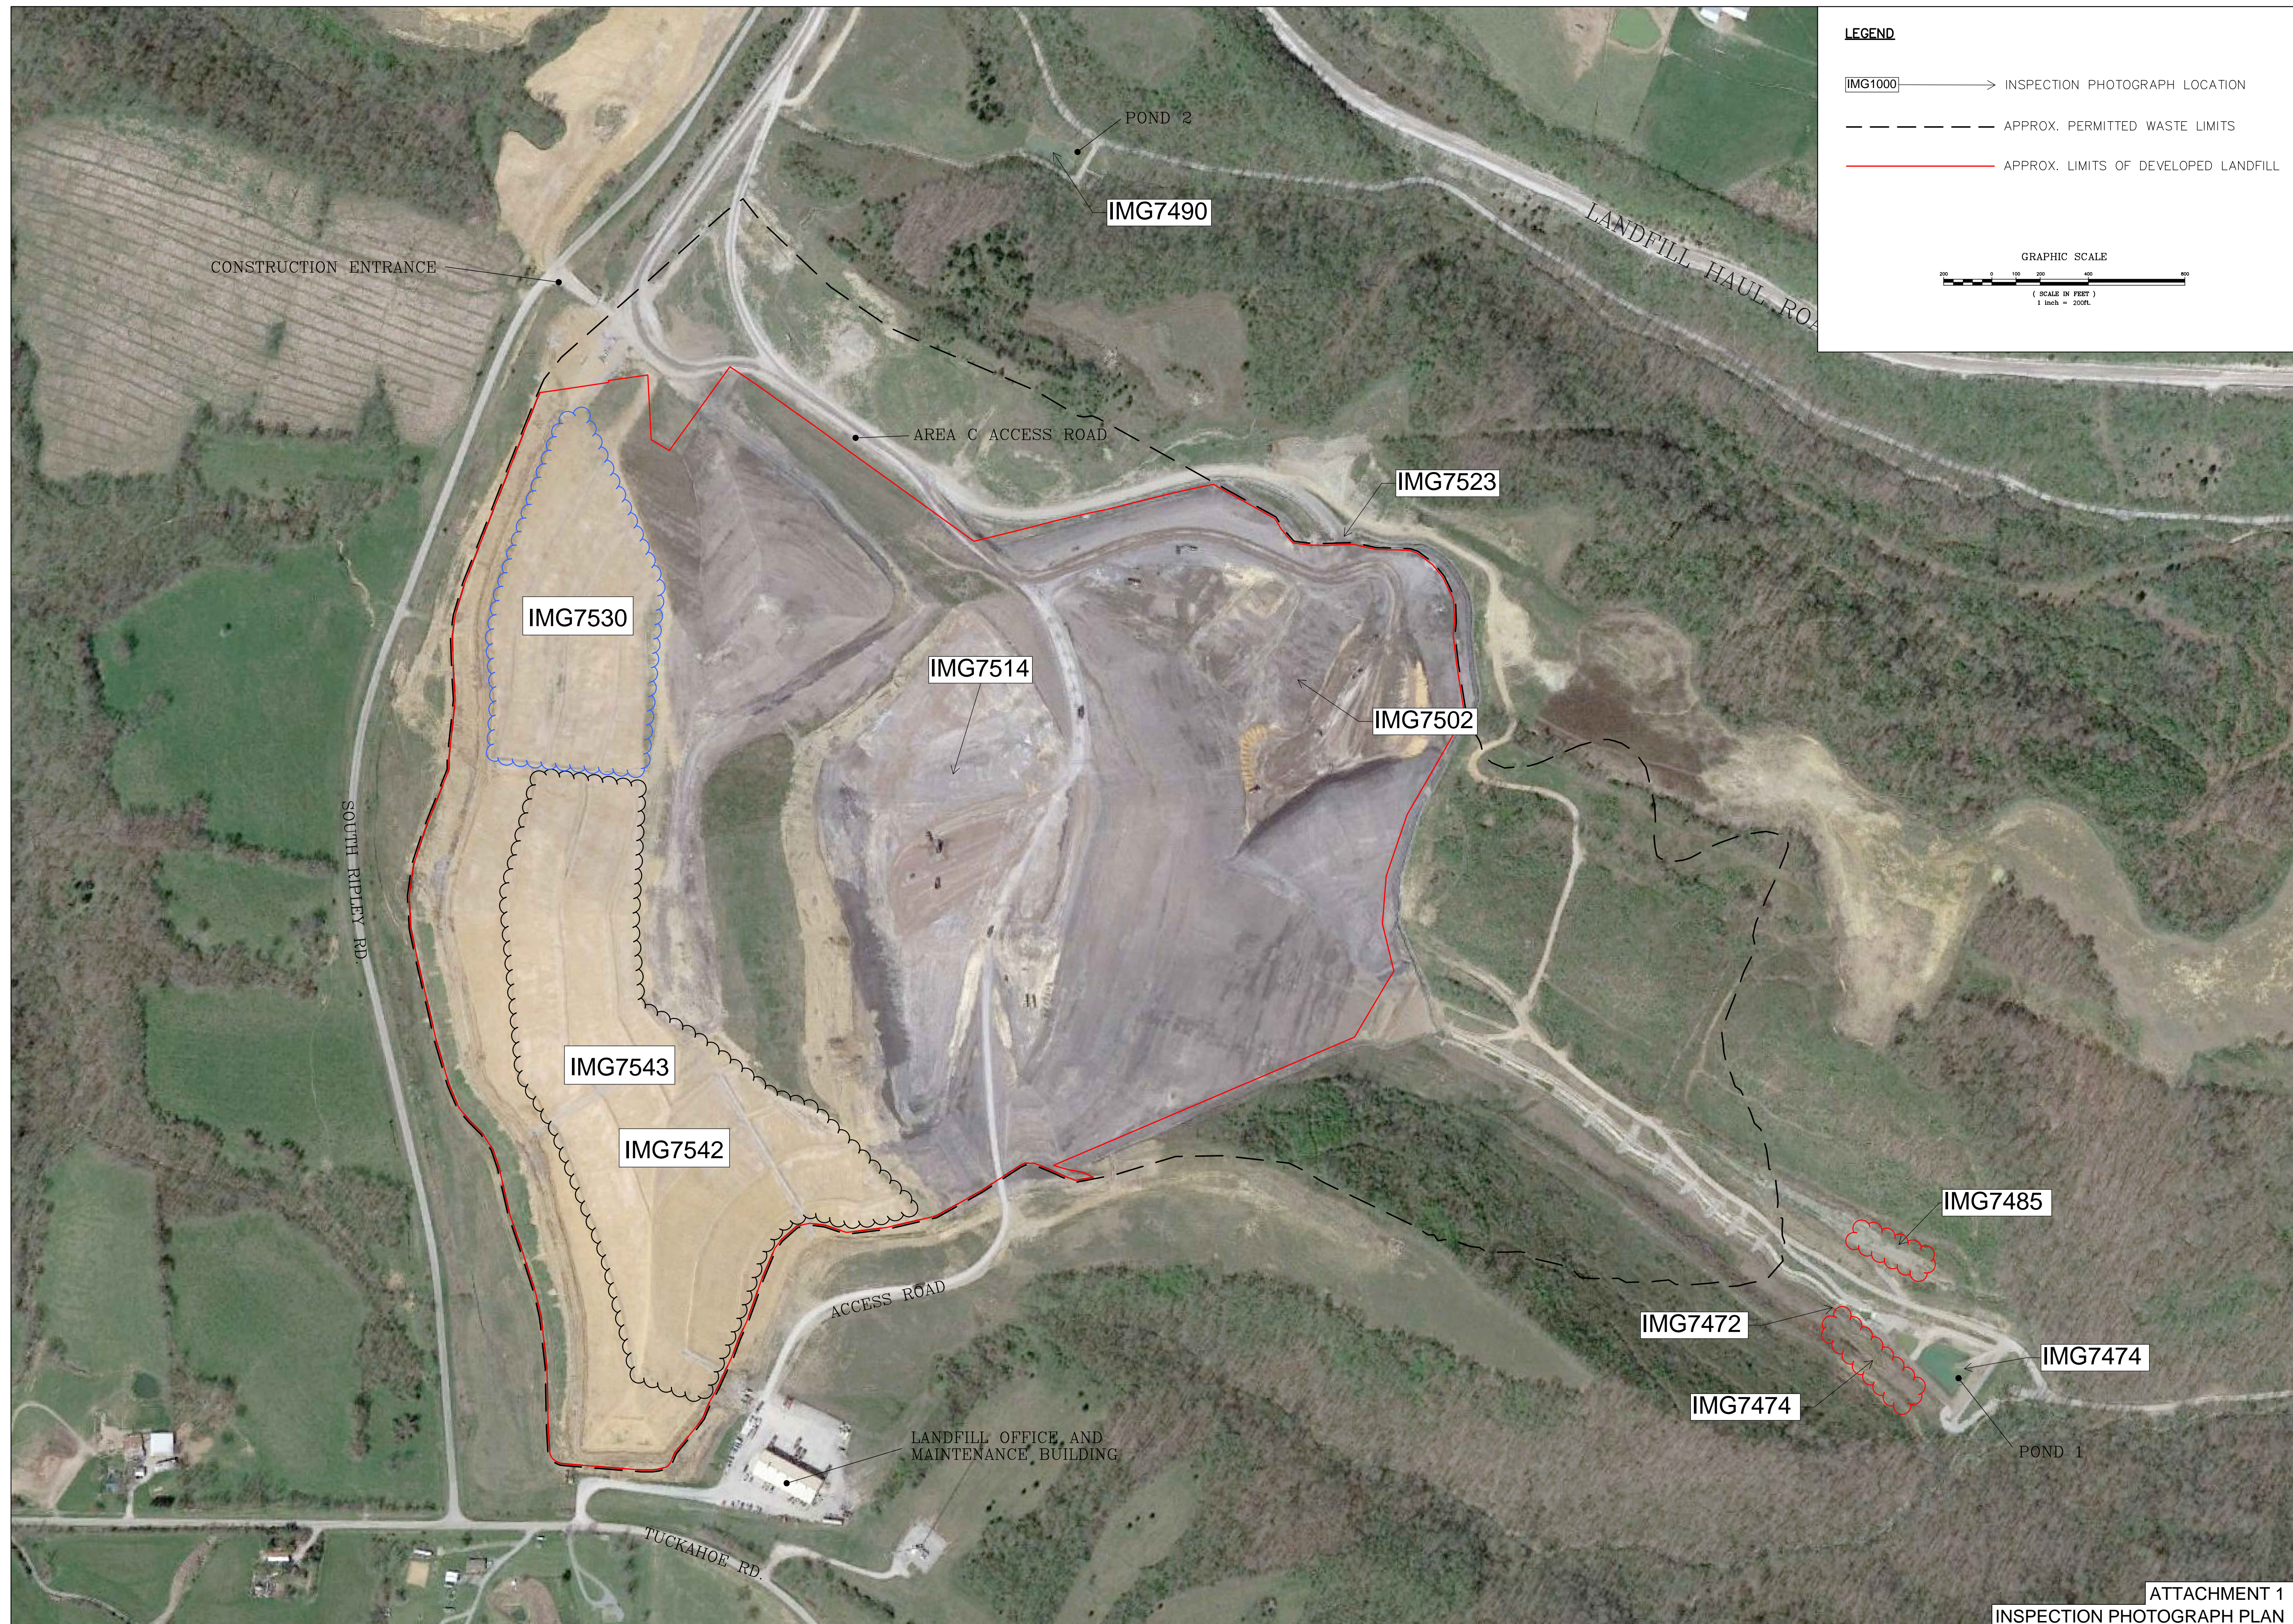
- 1) Concrete drainage ditch to Pond 1, damaged concrete at outlet due to impacts from slough on south slope above Pond 1. Repairs are planned by EKPC to take place during 2017 (Photo IMG-7472).

- 2) Soil slough above Pond 1 and concrete drainage ditch. This deficiency is currently being studied by EKPC to determine remedial measures (Photo IMG-7474). This item is located outside the landfill disposal footprint.

- 3) A slough was observed above Pond 1 on the north slope. This slough has been observed previously by EKPC and documented as moving slowly (Photo IMG-7485). This item is located outside the landfill disposal footprint.

- 6) Excessively tall and woody vegetation observed on portions of the final cover (Photo IMG-7530).
- 7) Lack of vegetation on portions of the final cover (Photo IMG-7542).
