SPURLOCK STATION LANDFILL PHASE 3-B CELL CONSTRUCTION

CCR RULE POST-CONSTRUCTION DESIGN CERTIFICATION

EAST KENTUCKY POWER COOPERATIVE

COAL COMBUSTION RESIDUAL RULE COMPLIANCE

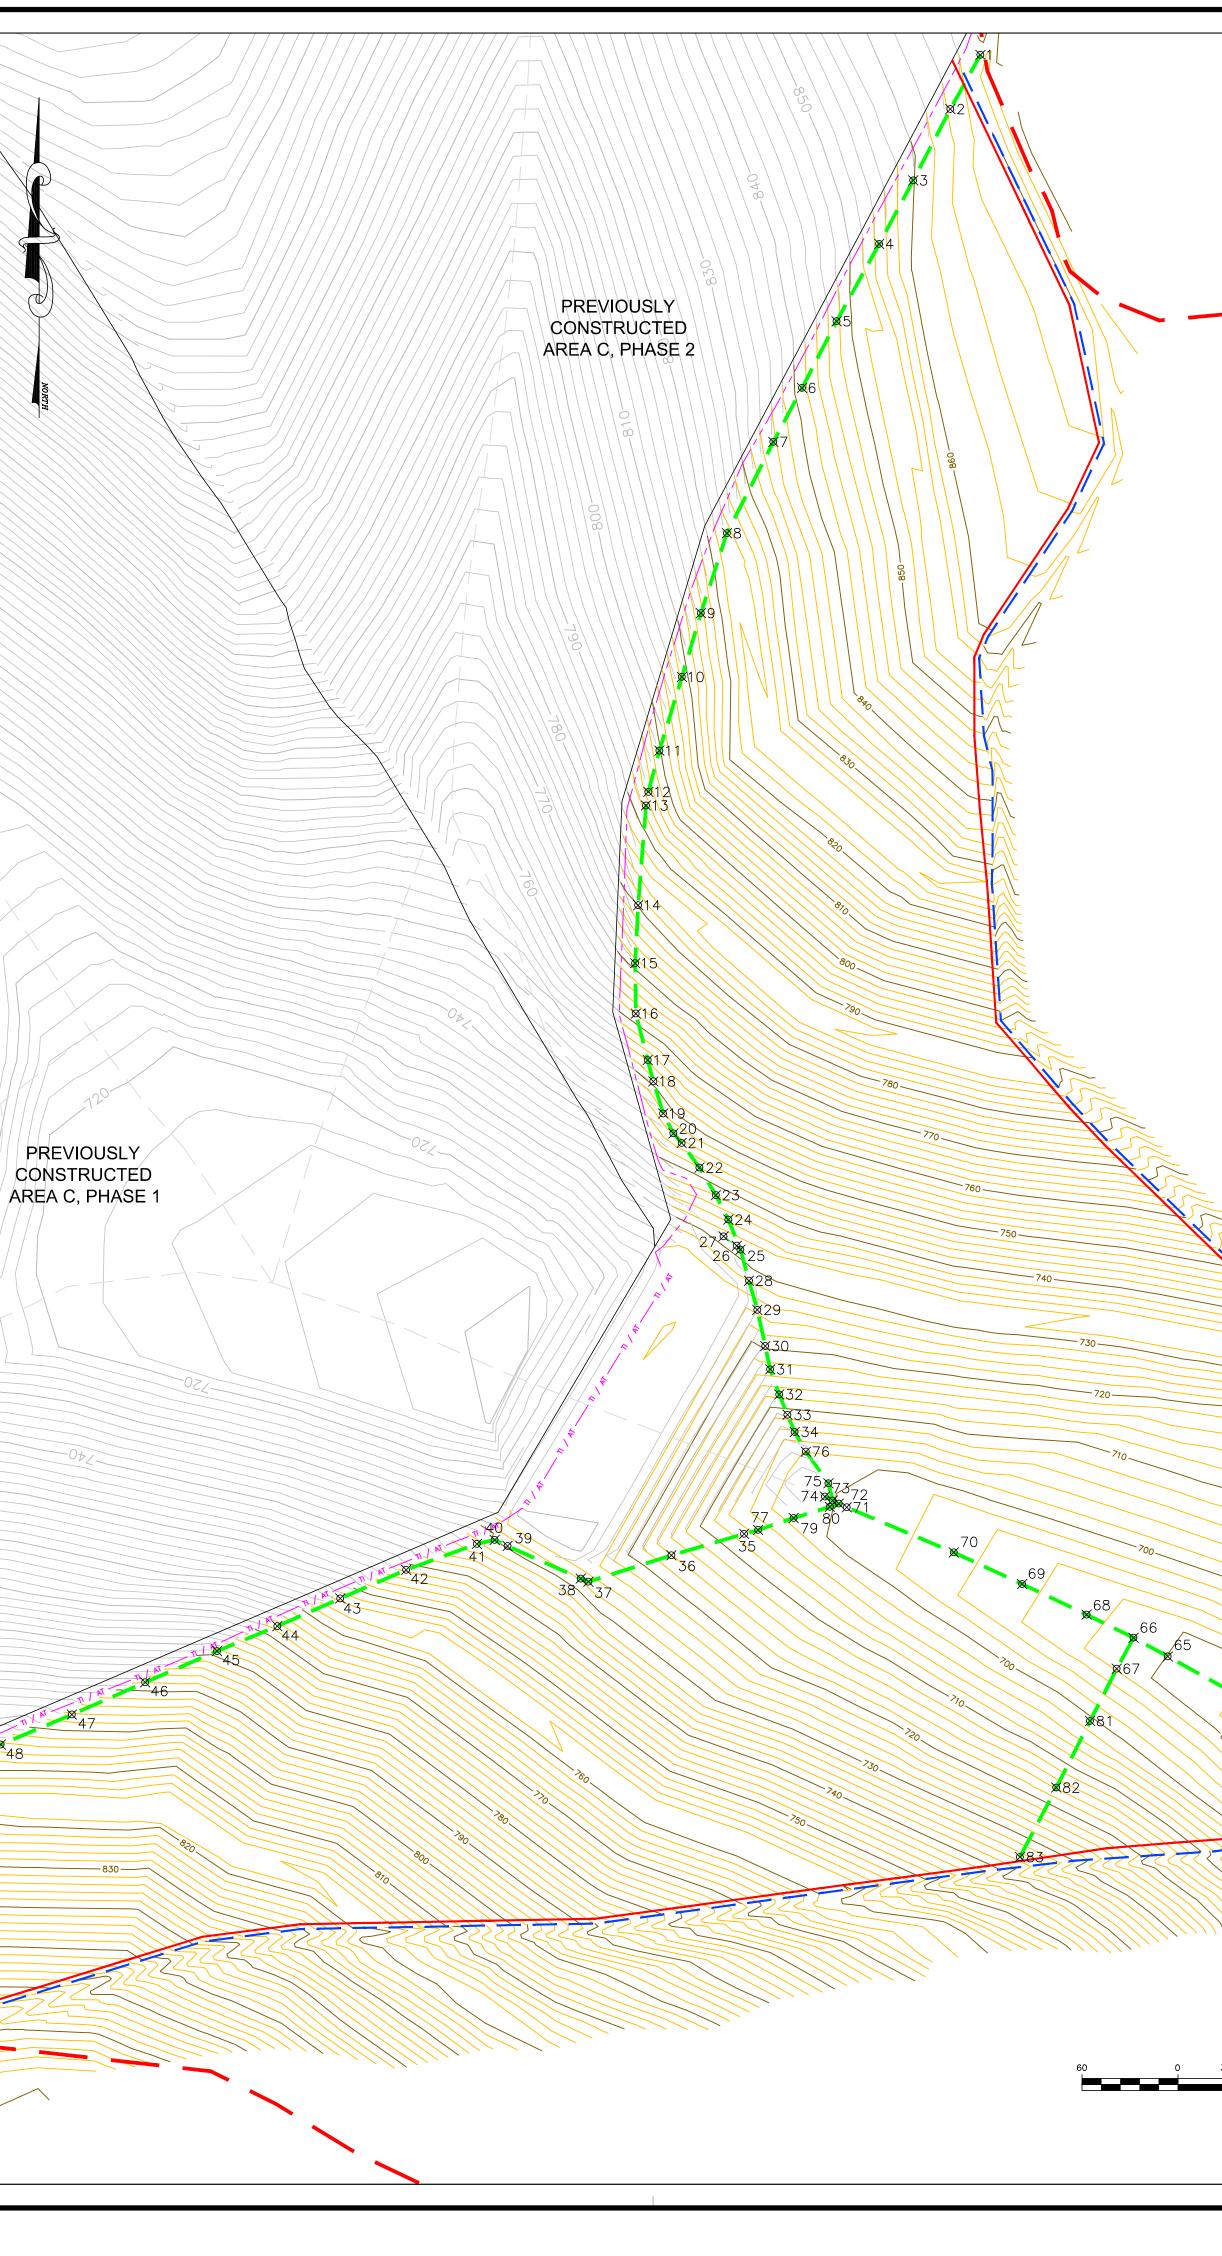
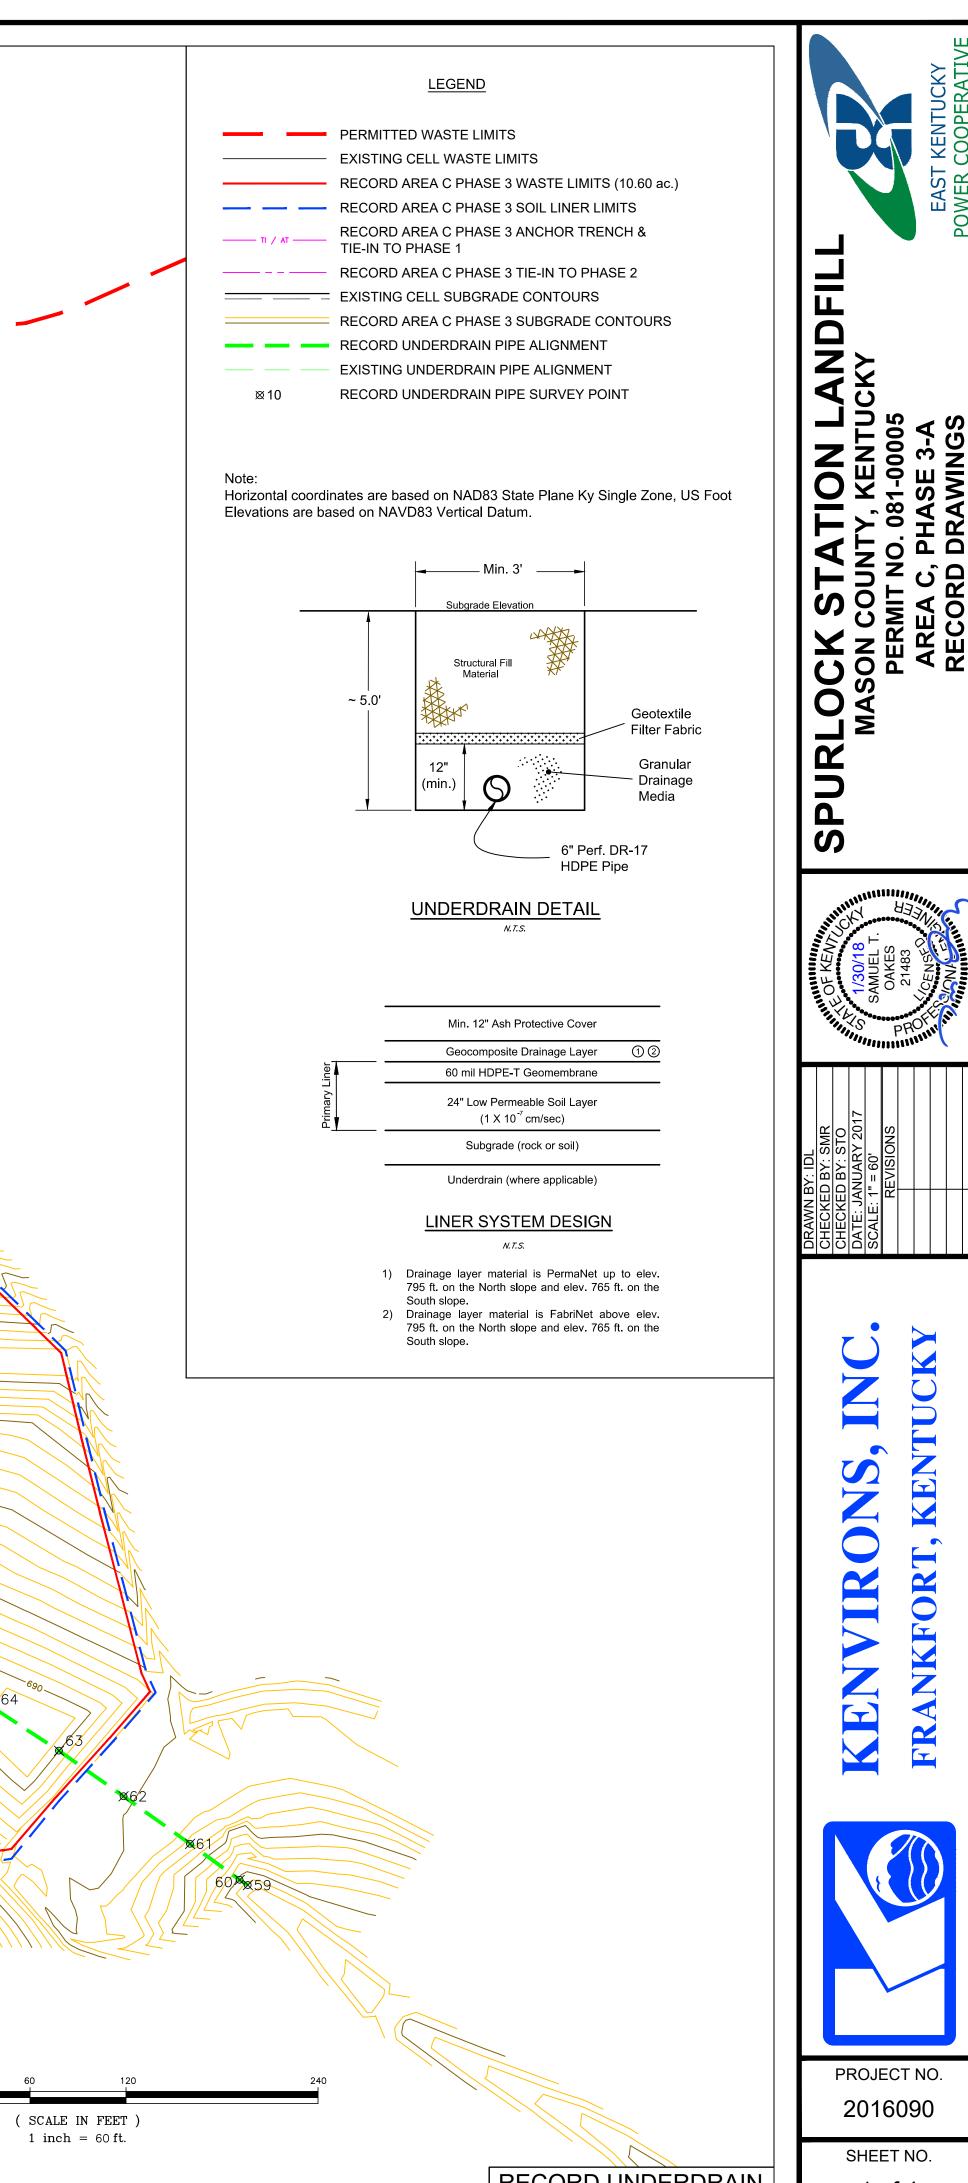
RECORD UNDERDRAIN

27		5467808.025	728.92	TOP OF PIPE TIE IN	68		5468034.944	688.16		
28		5467823.896	719.75		69		5467994.629	690.20		
29		5467829.109	717.00 713.28		70		5467951.888	692.21		$\langle \rangle \rangle$
30 31		5467834.089 5467837.171		TOP OF PIPE	71 72	4144091.078 4144093.326		694.75 694.98	TOP OF PIPE TOP OF PIPE TIE IN	
31		5467842.792	710.66	TOP OF PIPE	72		5467876.223	695.08	TOP OF PIPE TIE IN	
33		5467847.972	700.03	TOP OF PIPE	73		5467871.318	695.10	TOP OF PIPE TIE IN	
34		5467852.474		TOP OF PIPE	75		5467873.535	695.01	TOP OF PIPE ELBOW	\nearrow
35		5467820.889	701.58	TOP OF PIPE	76		5467859.448	698.40	TOP OF PIPE	-
36		5467775.417		TOP OF PIPE	77		5467829.618	700.13	TOP OF PIPE	740 X
37		5467723.546	722.45	TOP OF PIPE CORNER	79	4144084.374		696.15		$\langle \cdot \rangle$
38		5467718.755	722.68		80		5467874.396	695.23		
39 40	4144066.854	5467673.018	725.05 725.85	TOP OF PIPE TOP OF PIPE CORNER	81 82	4143957.507	5468037.059	696.86 710.84	TOP OF PIPE	-////

40		5467653.844			83		5467993.244	725.79	TOP OF PIPE END	-/////
				820 800						
				820	780					
	800			820 800	780					
				800	780					
	800			800	780					
				800	780					
				800						
				800						
				800					× 51 50	49
				800		11M ¥ 55				49

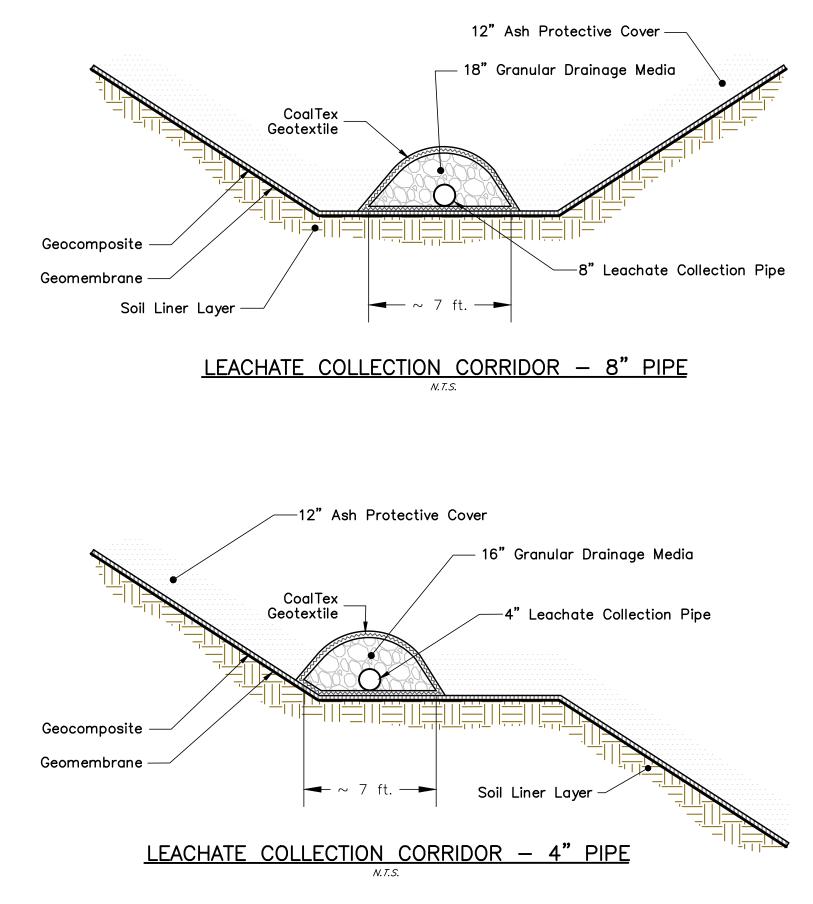
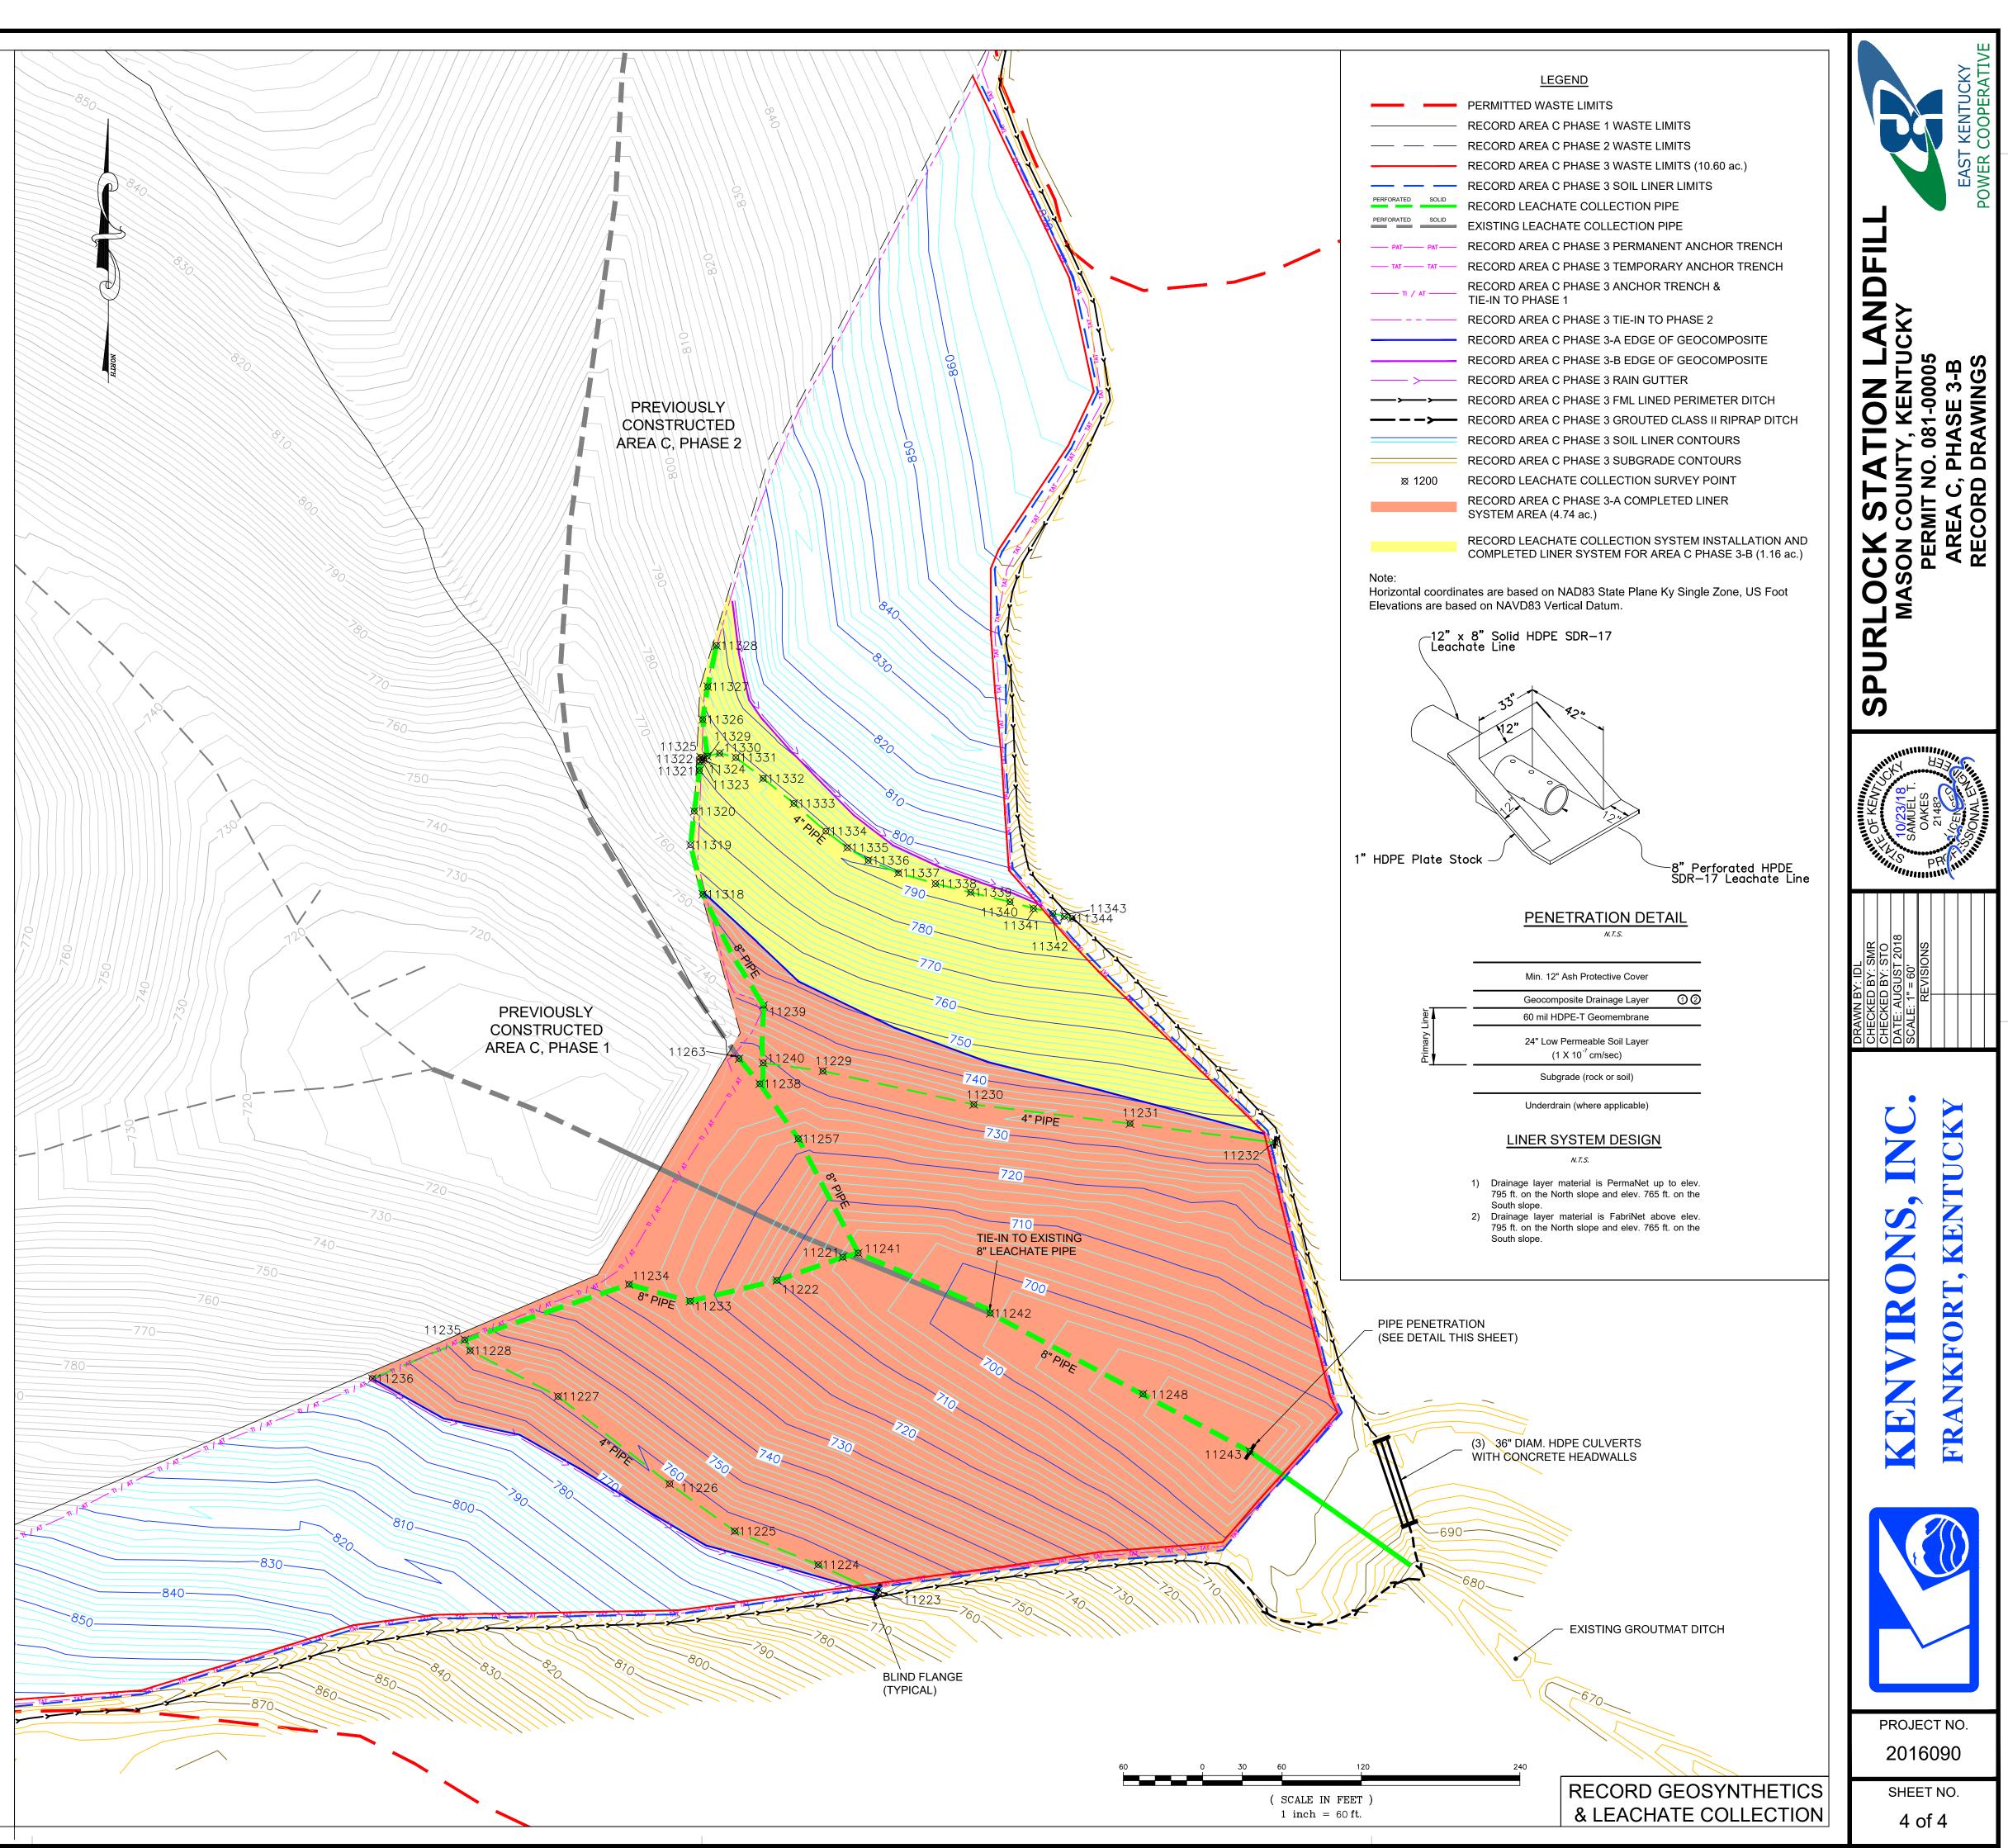
POINT NUMBER	NORTHING	EASTING	ELEVATION	DESCRIPTION
11221	4144101.16	5467852.63	703.13	leachate collection pipe
11222	4144083.59	5467802.79	711.04	leachate collection pipe
11223	4143847.37	5467879.60	761.79	leachate collection pipe
11224	4143868.44	5467834.13	761.76	leachate collection pipe
11225	4143893.82	5467770.95	761.45	leachate collection pipe
11226	4143929.60	5467721.61	760.70	leachate collection pipe
11227	4143995.82	5467637.14	759.35	leachate collection pipe
11228	4144030.47	5467570.68	757.82	leachate collection pipe
11229	4144242.08	5467837.57	732.52	leachate collection pipe
11230	4144216.79	5467951.79	733.92	leachate collection pipe
11231	4144202.33	5468070.11	735.08	leachate collection pipe
11232	4144187.96	5468179.89	735.81	leachate collection pipe
11233	4144067.88	5467737.09	725.49	leachate collection pipe
11234	4144080.61	5467690.86	727.93	leachate collection pipe
11235	4144038.68	5467566.58	756.70	leachate collection pipe junctio

11236	4144009.35	5467496.54	779.05	leachate collection pipe junctio
11237	4144009.44	5467496.53	779.02	leachate collection pipe
11238	4144232.44	5467789.83	727.23	leachate collection pipe
11239	4144291.79	5467792.73	741.17	leachate collection pipe
11240	4144248.28	5467792.41	729.37	leachate collection pipe
11241	4144104.30	5467864.41	702.64	leachate collection pipe wye
11242	4144058.75	5467964.27	698.37	wye tie-in to existing pipe
11243	4143954.16	5468160.76	690.18	solid pipe/ penetration assemb
11248	4143997.66	5468079.93	694.57	leachate collection pipe
11257	4144190.79	5467819.06	725.33	leachate collection pipe
11263	4144251.50	5467774.13	729.58	tie-in to existing leachate pipe
11318	4144375.814	5467746.696	756.247	top 8" leachate pipe
11319	4144413.23	5467737.41	765.073	top 8" leachate pipe
11320	4144438.673	5467740.237	772.531	top 8" leachate pipe
11321	4144469.555	5467744.261	780.397	top 8" leachate pipe

11322	4144476.185	5467744.564	781.81	top 8" leachate tee
11323	4144477.638	5467746.261	782.813	top 8" leachate pipe
11324	4144478.422	5467747.292	783.194	top 8"leachate pipe connector to
11325	4144479.618	5467745.006	782.584	top 8" leachate pipe
11326	4144508.153	5467746.572	788.697	top 8" leachate pipe
11327	4144533.04	5467750.433	792.352	top 8" leachate pipe
11328	4144564.088	5467757.034	797.831	top 8" leachate pipe
11329	4144480.477	5467750.132	784.482	top 4"leachate pipe
11330	4144482.647	5467759.417	787.49	top 4"leachate pipe
11331	4144479.41	5467771.729	789.669	top 4"leachate pipe
11332	4144463.529	5467792.389	789.631	top 4"leachate pipe
11333	414444.667	5467815.609	789.872	top 4"leachate pipe
11334	4144423.595	5467839.785	789.908	top 4"leachate pipe
11335	4144411.155	5467856.12	790.178	top 4"leachate pipe
11336	4144401.53	5467871.953	790.285	top 4"leachate pipe
11337	4144392.053	5467894.798	790.473	top 4"leachate pipe

11338	4144383.905	5467922.826	790.744	top 4"leachate pipe
11339	4144377.293	5467949.454	791.01	top 4"leachate pipe
11340	4144370.107	5467979.221	791.416	top 4"leachate pipe
11341	4144365.14	5467996.975	791.551	top 4"leachate pipe
11342	4144361.382	5468011.637	791.892	top 4"leachate pipe
11343	4144359.137	5468020.304	790.629	top 4"leachate pipe
11344	4144357.615	5468026.155	788.25	top 4"leachate pipe
